**Brian Kruchkow**  
**1001 Sayles Blvd**  
**Abilene, TX 79605**

**December 18, 2023**

# PROPERTY INSPECTION REPORT FORM

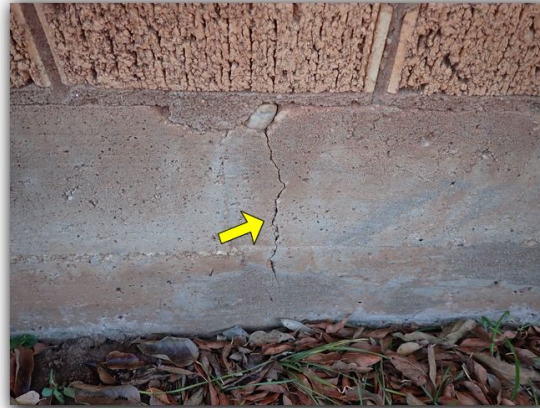
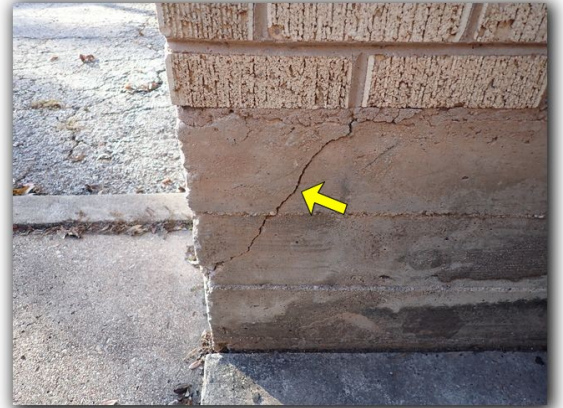
- One or more of the foundation perimeter beam corners were observed to be sheared off (corner pop). This is a common condition to observe and is do to thermal expansion and contraction of the different building materials. This condition does not adversely affect the foundation performance. However, in some cases, some cosmetic improvements may be necessary.
- Typical stress crack(s) were observed in the exterior foundation perimeter beam.

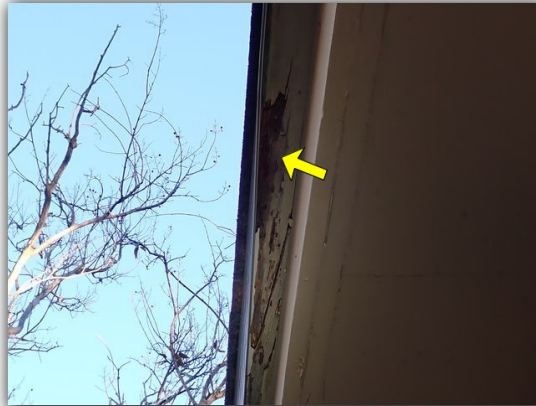
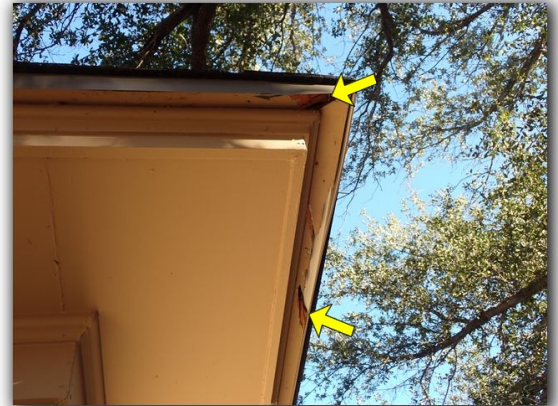
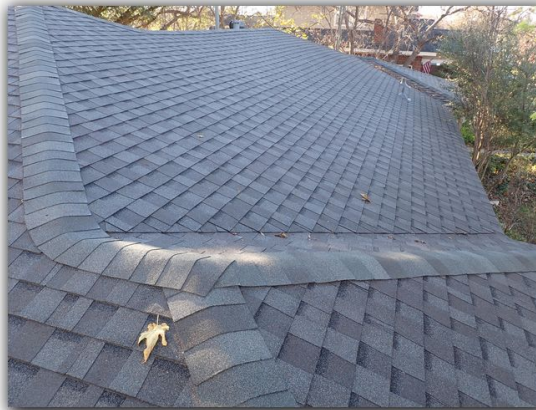
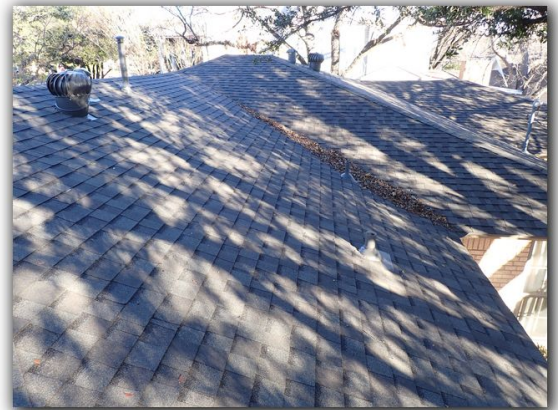
- Some of the drip edge trim was observed to be damaged and/or deteriorated.

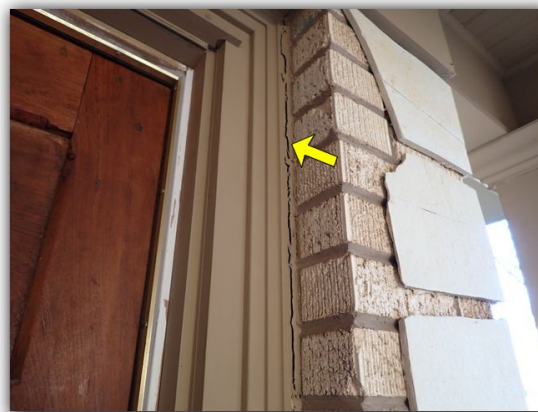
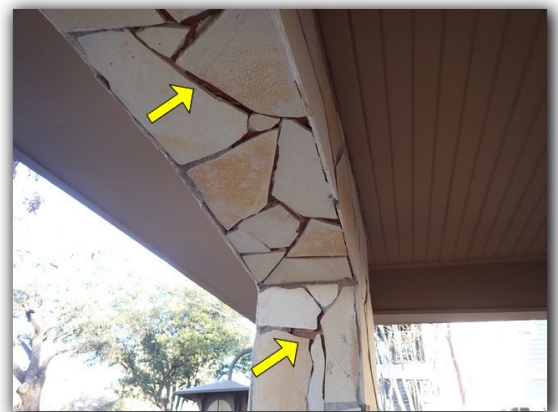
- Caulking improvements are recommended for the area between the exterior veneer and the window frames. It is recommended to use an industry approved low-modulus elastomeric sealant (exterior caulking).
- Caulking improvements are recommended for the area between the exterior veneer and the exterior door frames. It is recommended to use an industry approved low-modulus elastomeric sealant (exterior caulking).
- Mortar improvements are recommended for the exterior masonry veneer on the west side of the structure.

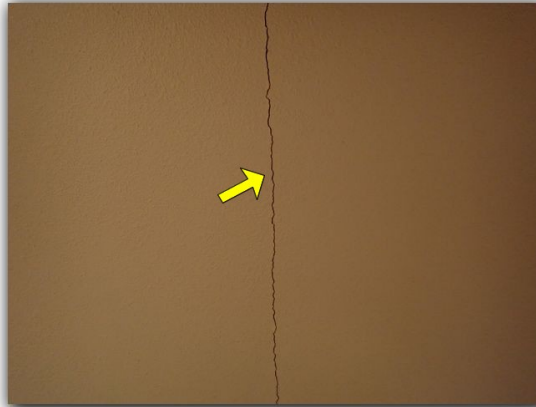
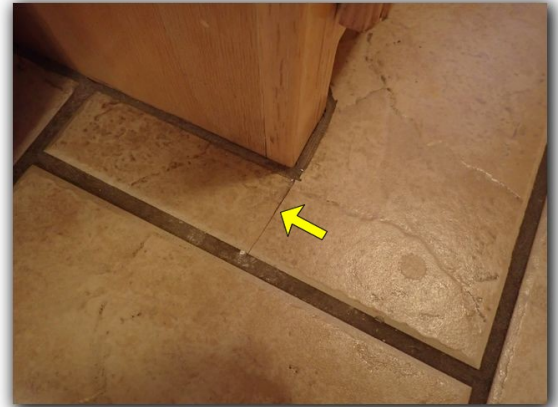
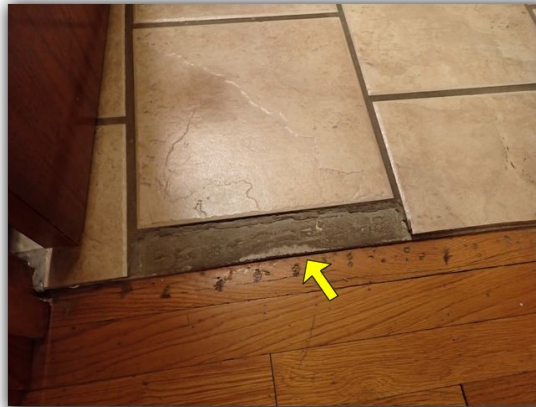
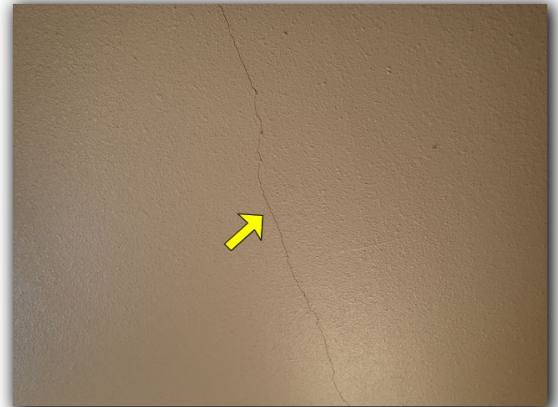
- The floor tile(s) were observed to be cracked and/or missing in hall bathroom.

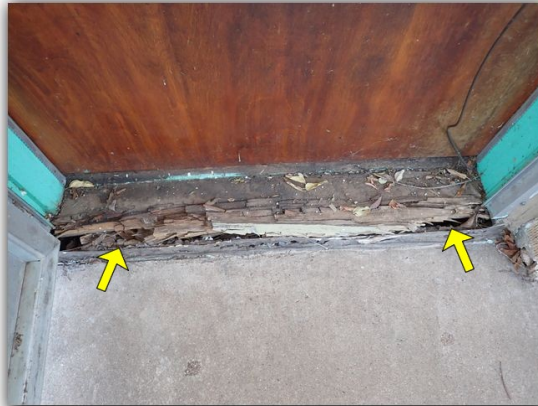
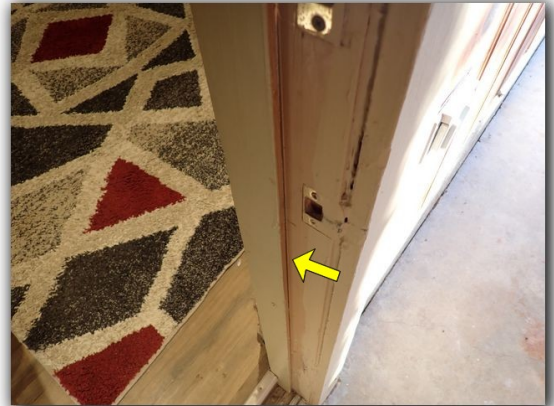
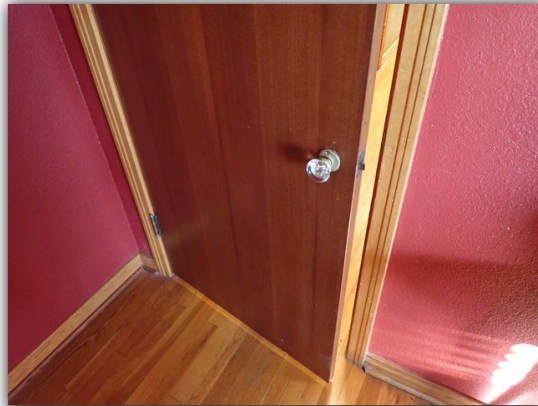
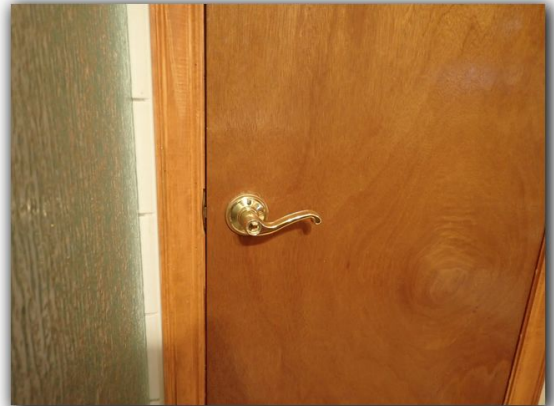
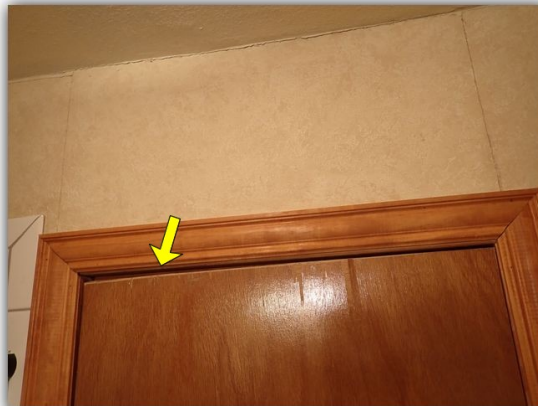
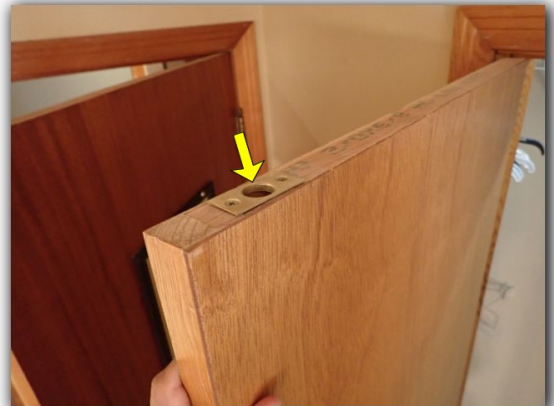
- The door(s) are not latching properly and/or sticking in rear corner bedroom, master bathroom. Recommend minor adjustments to the jams, hinges and/or striker plates as needed.
- One or more of the interior doors are out of square and have been shaven at the top to help them fit the opening. This may be due to adverse foundation performance.
- The door hardware is missing to the master bedroom closet.

- The exterior door threshold has some deterioration and/or damage to the side yard entry.
- Weather-stripping improvements are recommended for the guest bedroom exterior door(s).

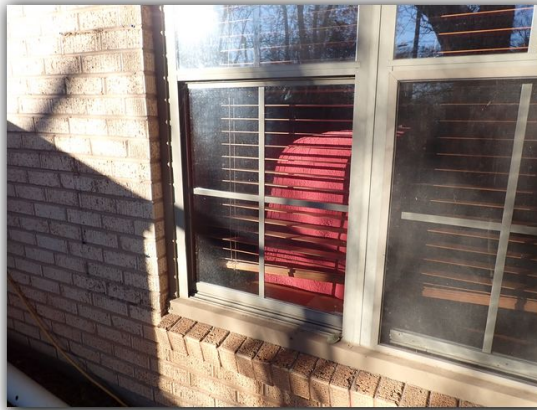
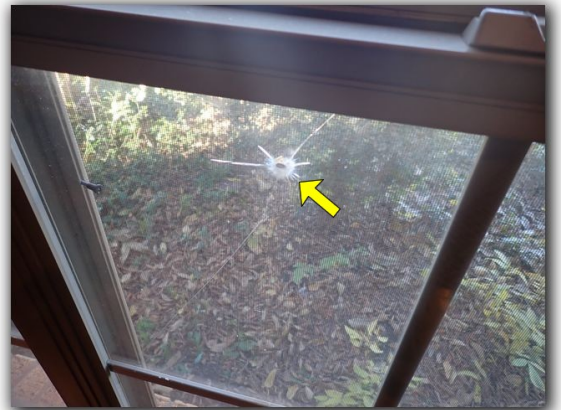
- One or more of the window screens were observed to be missing.

- Cracked and/or broken window glass was observed in the master bedroom.
- **Note:** I was unable to inspect the operation of some of the windows due to window treatments, personal effects, large, heavy or fragile storage and/or furniture.

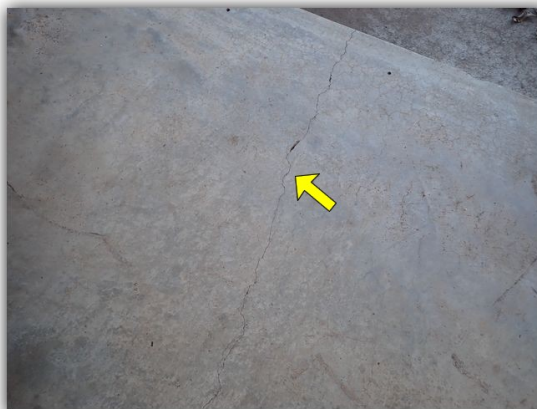
- Some typical cracking of the patio concrete flatwork was observed.

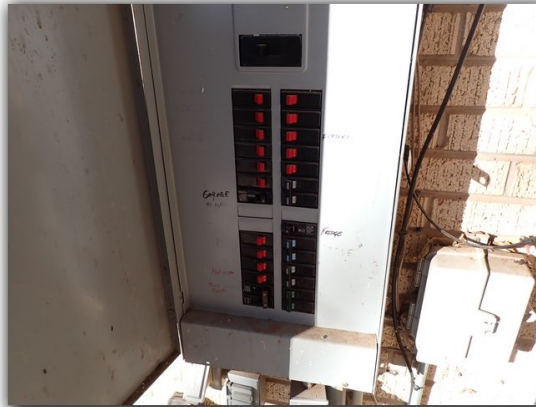
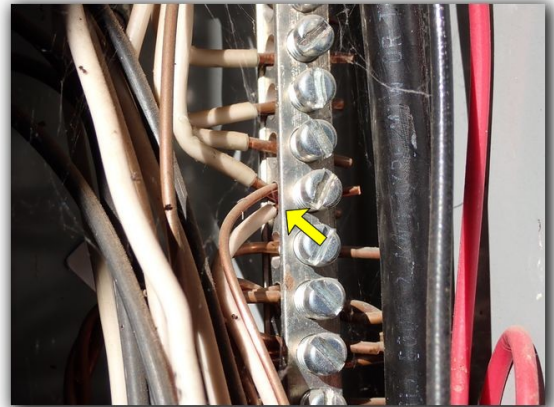
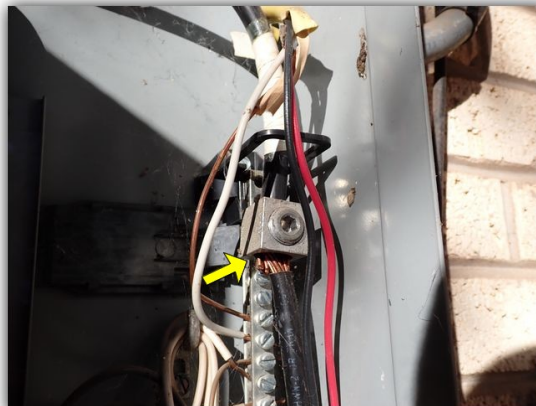
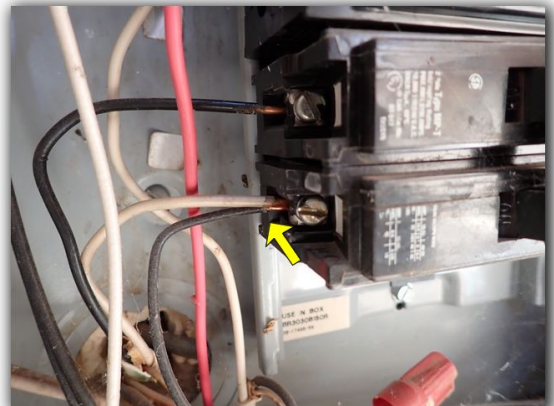
- The breakers (overcurrent devices) in the electrical panel are not properly labeled.
- One or more of the cabinet cover plate screws are missing and need to be replaced.
- The electrical cabinet does not appear to be properly bonded to the electrical system.
- There are multiple neutral wires secured under one lug/screw on the neutral bus bar. This type of installation does not meet current electrical standards. These conditions may not have violated building codes or common practices at the time of the construction of the home, or they may have been “grandfathered” because they were present prior to the adoption of codes prohibiting such conditions.
- One or more of the breakers in the electrical cabinet were observed to be double lugged (i.e. two wires under one screw). The breakers in place are not listed or labeled for this type of installation and should be corrected as necessary.

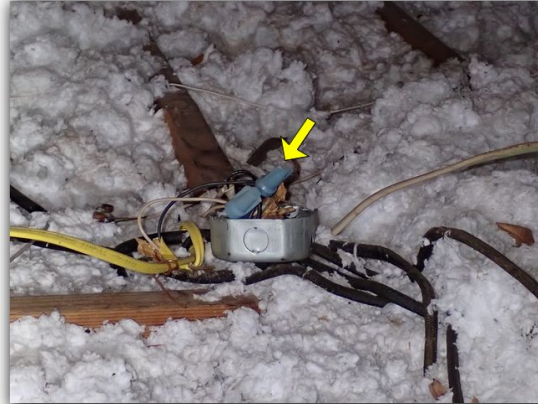
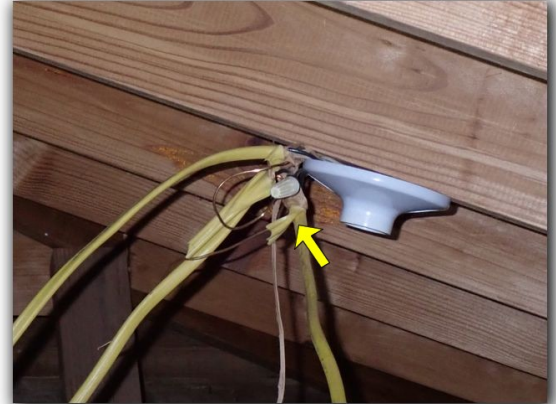
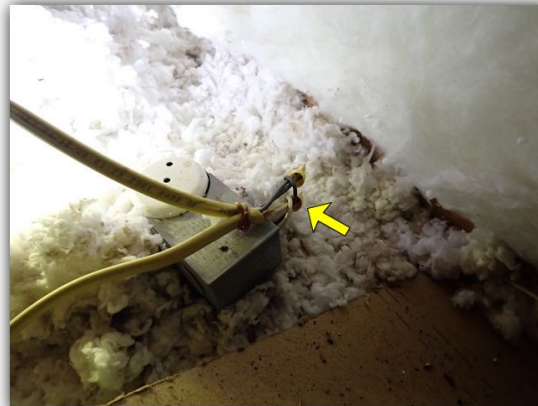
- Open electrical junction box(es) were observed in the attic area. All open junction box(es) in the attic should be properly enclosed.
- Spliced electrical wires were observed in the attic area. Spliced wires in the attic should be properly enclosed in junction box(es) and secured to the ceiling joist.
- Electrical wires were observed to be lying on the ground in the crawl space area. The wires lying on the ground in the crawl space should be raised and properly secured to a floor joist or beam.

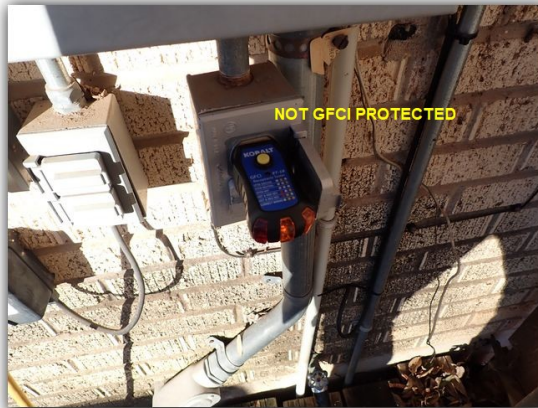
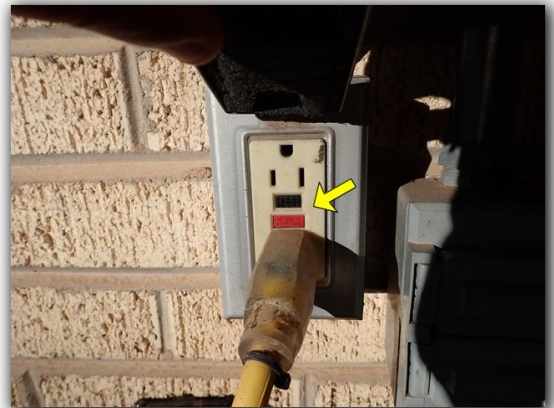
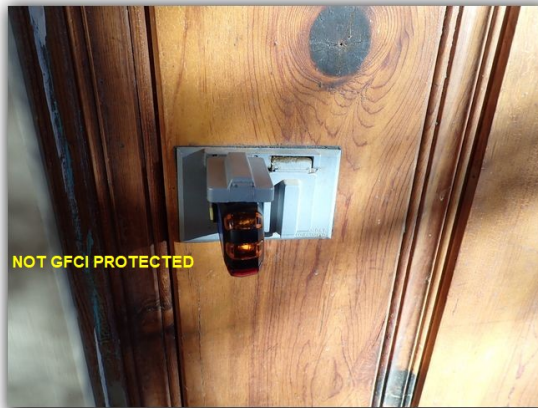
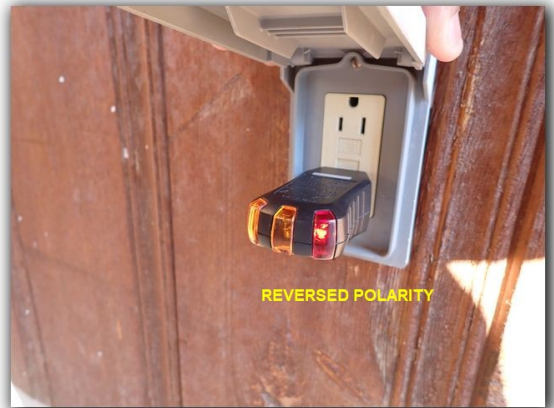
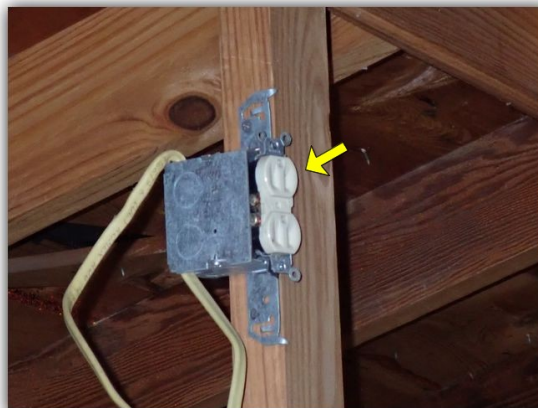
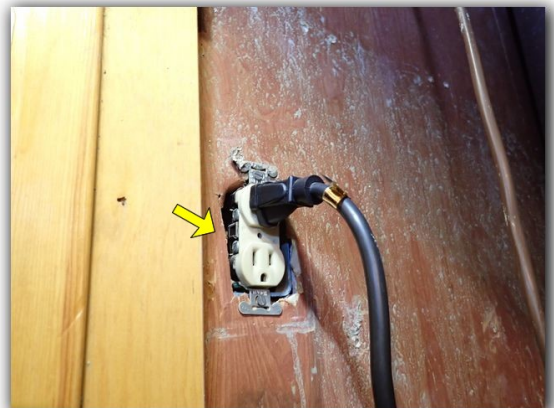
- One or more of the receptacles appear to have reversed polarity (i.e. it is wired backwards). This receptacle(s) and the circuit should be investigated and improved as necessary. The receptacle(s) in question are located in the east exterior wall.
- Most to all of the three-prong receptacles are observed to be ungrounded. This is an older two-wire system. **Note:** Placing three prong receptacles on an older two-wire system does not meet current National Electrical Code standards.
- One or more of the receptacles is missing its cover plate in the bedroom hallway closet and attic.

- The clothes dryer receptacle does not appear to be connected to a ground fault circuit interrupter (GFCI) device. Under current electrical standards, all 125-volt through 250-volt (Including Dryer) receptacles installed in laundry areas should have GFCI protection. This may be an “as-built” condition but Per TREC standards of practice we are required to report this condition as a deficiency. After closing, you may consider corrective measures for improved safety.

- The kitchen counter top receptacles do not appear to be connected to a ground fault circuit interrupter (GFCI) device. Under current electrical standards, all 125-volt through 250-volt receptacles that serve countertop surfaces and any receptacle within 6-feet of the sink should have GFCI protection. This may be an “as-built” condition but Per TREC standards of practice we are required to report this condition as a deficiency. After closing, you may consider corrective measures for improved safety.

- Not all of the exterior receptacles appear to be connected to a ground fault circuit interrupter (GFCI) device. Under current electrical standards, all 125-volt through 250-volt receptacles installed outdoors should have GFCI protection. This may be an “as-built” condition but Per TREC standards of practice we are required to report this condition as a deficiency. After closing, you may consider corrective measures for improved safety.

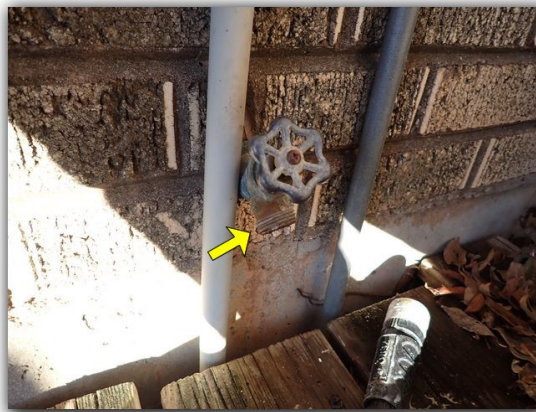
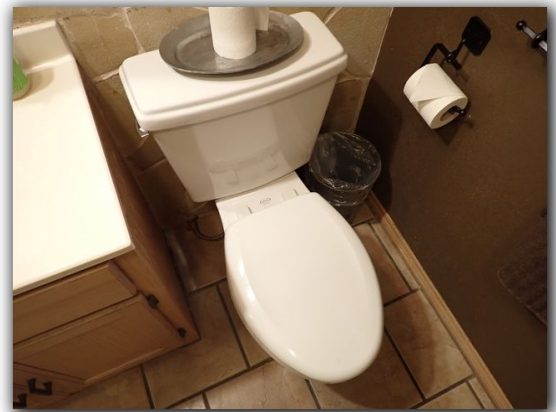
- The commode is loose at the floor mount.

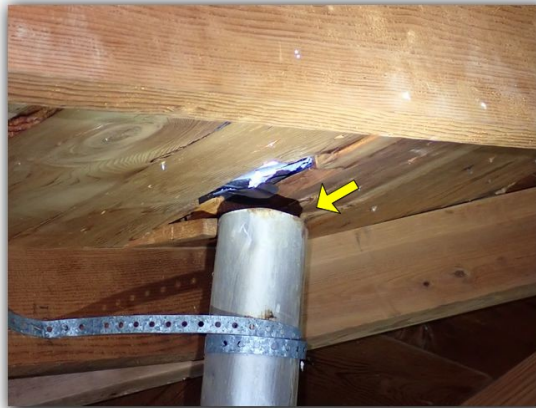
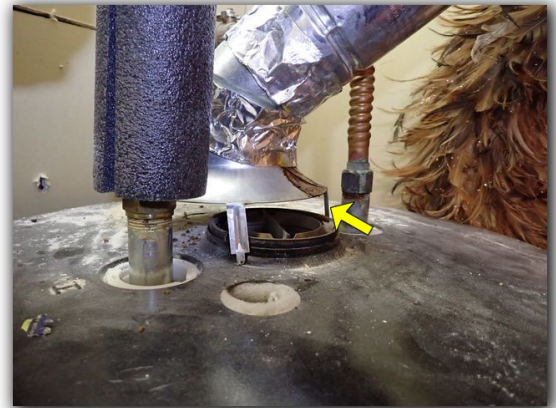
- The vent pipe is not properly mounted at the top of the water heater. This configuration will emit Carbon Monoxide into the heater compartment, which is a known safety hazard.
- The water heater flue connector should be mechanically attached to the draft hood with a minimum of three sheet metal screws.
- The water heater vent pipe is separated in the attic. This configuration will emit Carbon Monoxide into the attic area, which is a known safety hazard.

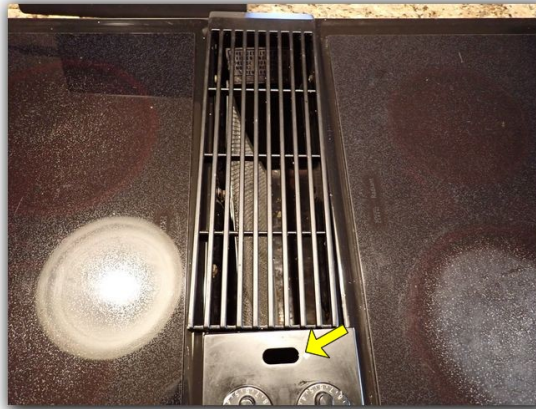
- The exhaust system button was observed to be missing.

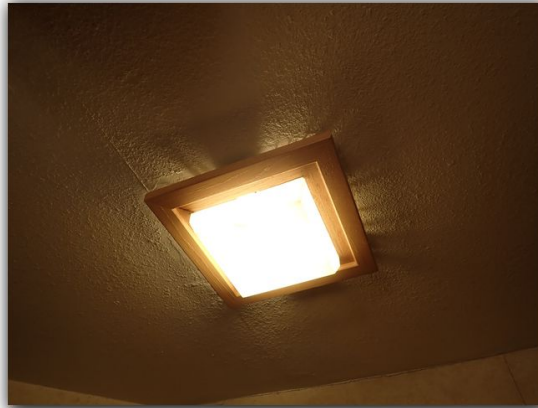
- The mechanical exhaust vent fan was unusually noisy in the master bathroom.
- **Note:** The bathroom exhaust vents were observed to be venting into the attic area and not to the exterior of the structure. This is an “as-built” condition per local building codes but we are required to mark it as deficient per the TREC standards of practice.

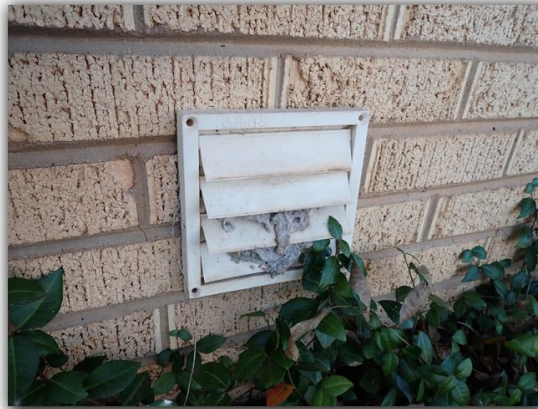
- The dryer exhaust duct (vent pipe) is dirty and needs to be cleaned.
