**December 18, 2023**

# PROPERTY INSPECTION REPORT FORM

1002 & 1002.5 Amarillo St, Abilene, TX 79602

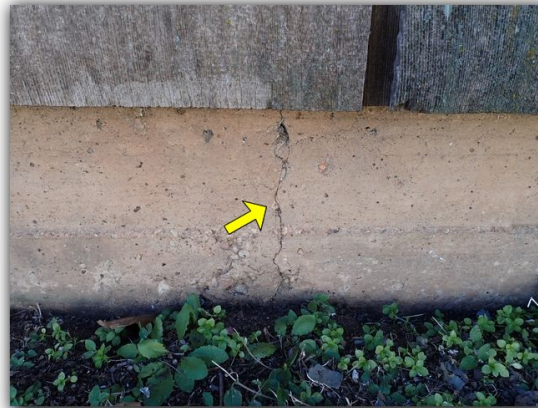
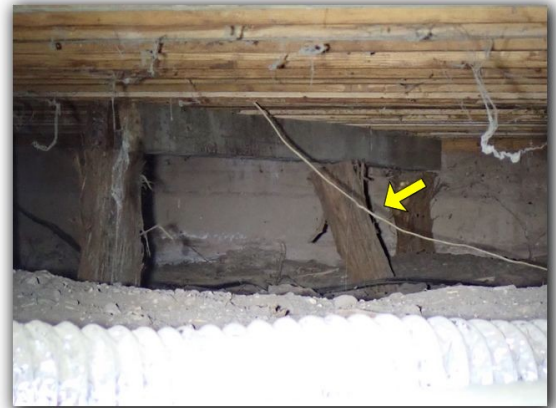
- Typical stress crack(s) were observed in the exterior foundation perimeter beam.
- One or more of the support piers was observed to be leaning. This condition may cause floors to become out of level. This condition should be further evaluated and corrected as necessary.

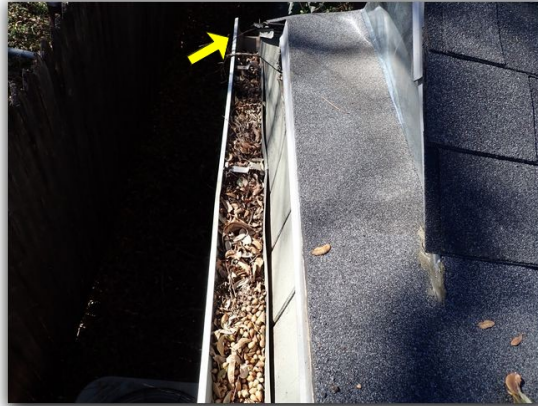
- The gutters require cleaning.
- The gutter end cap is missing.
- The guttering system downspout is missing.

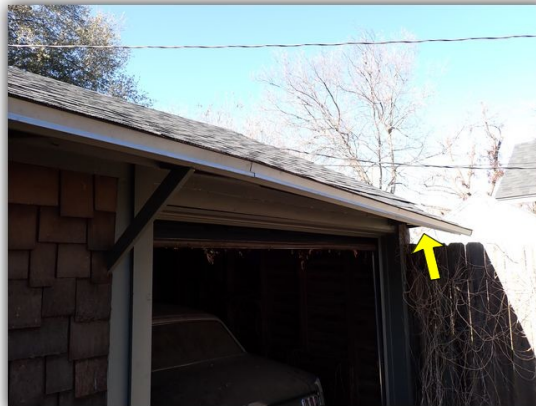
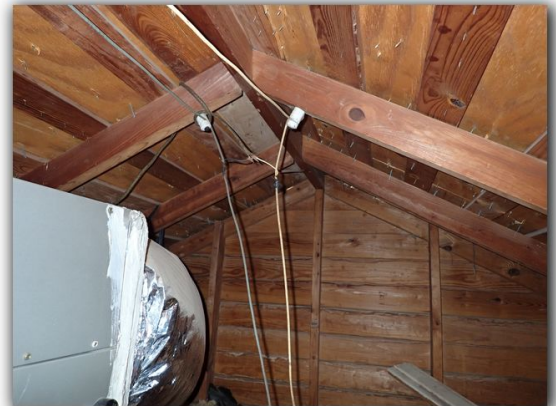
- The roof decking was observed to sag at the detached garage area.

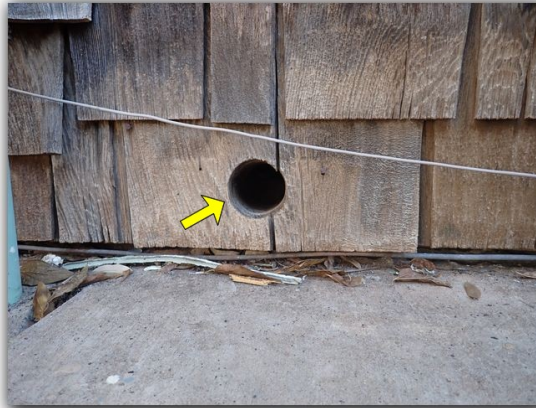
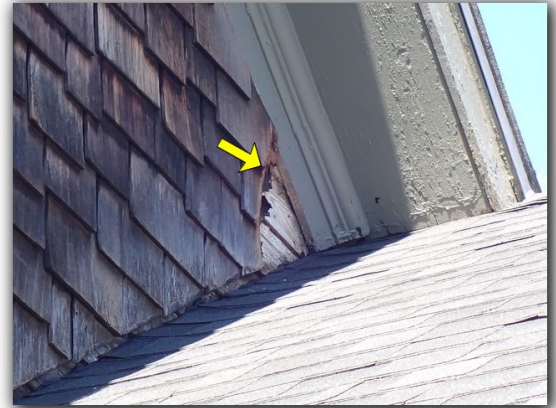
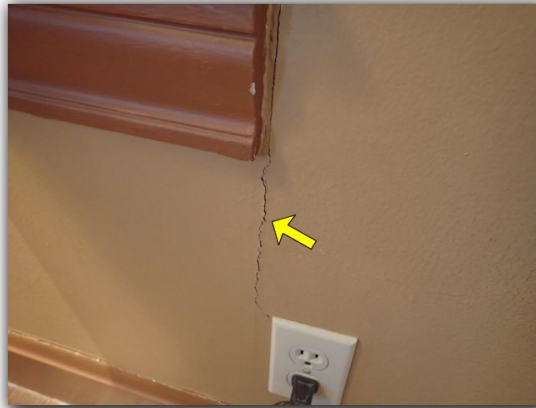
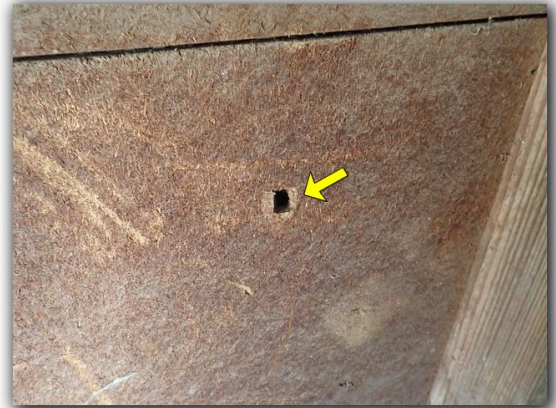
- Note:** There is evidence of painting and patching to the interior finish and prior interior finish repairs. This condition could limit the Inspectors visual observations and ability to render accurate opinions as to the performance of the structure.
- Interior wall stress cracks were observed in the various locations throughout the structures.
- Wall surface damage was observed in the garage.

- Opening on the exterior wall was observed on the west side of the structure.
- The exterior veneer / cladding has some deterioration and/or damage on the east side of the structure.

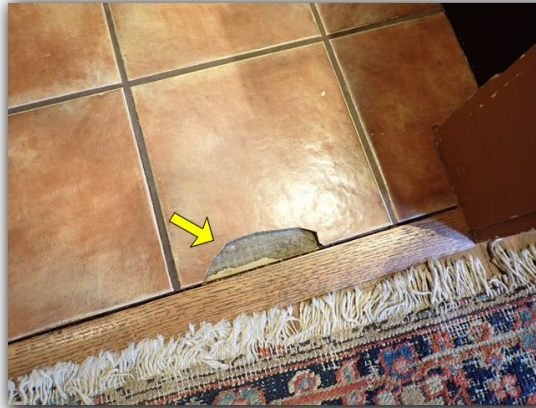
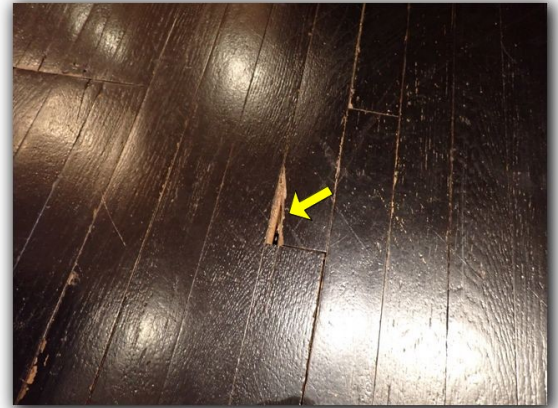
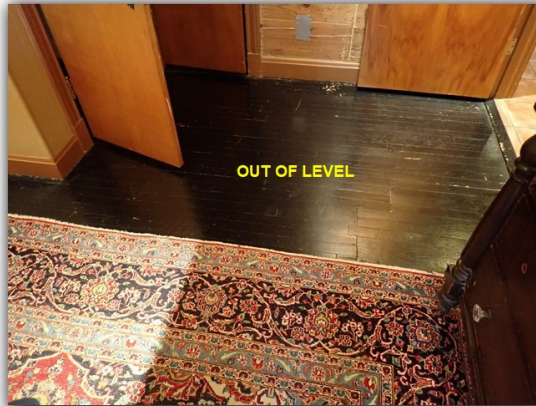
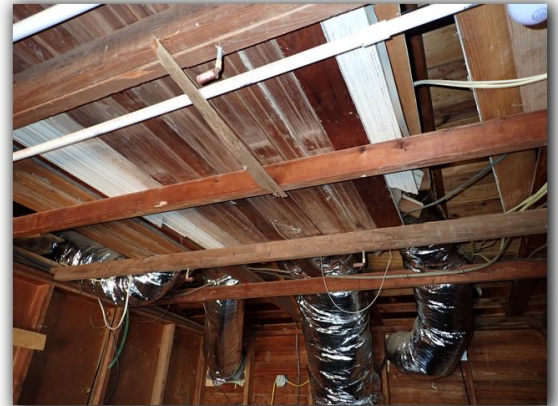
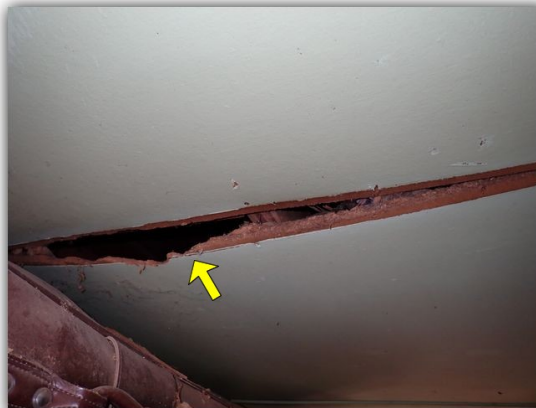
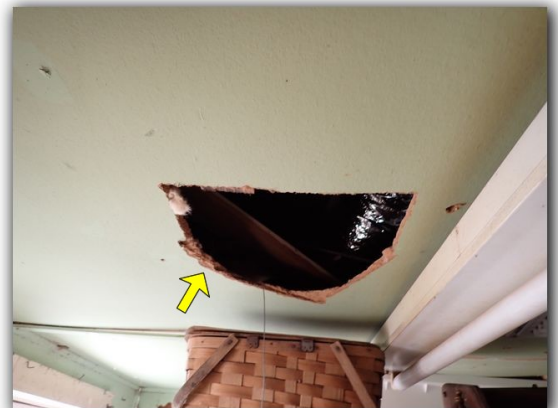
- **Note:** There is evidence of painting and patching to the interior finish and prior interior finish repairs. This condition could limit the Inspectors visual observations and ability to render accurate opinions as to the performance of the structure.
- The garage ceiling is opened to the attic space. Under current building standards the garage ceiling should be enclosed / separated from the attic space.
- The ceiling was observed to be damaged in the garage area.

- The floor tile(s) were observed to be cracked and/or damaged in kitchen.
- The floors were observed to be out-of-level in some areas of the house.
- The floor covering is noticeably worn and/or damaged in one or more locations of the home.

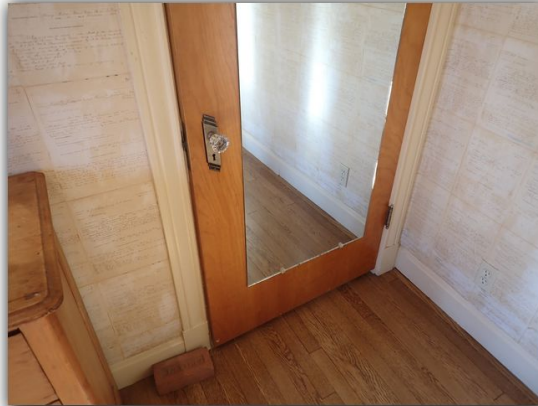
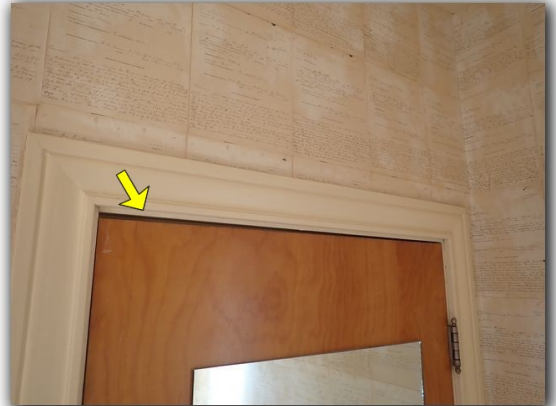
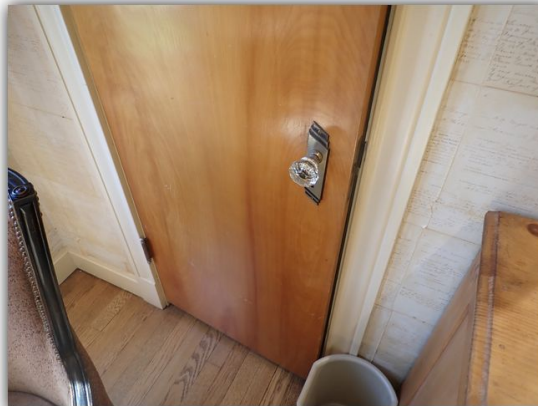
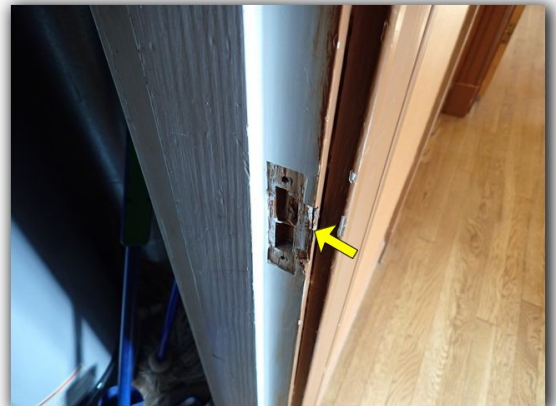
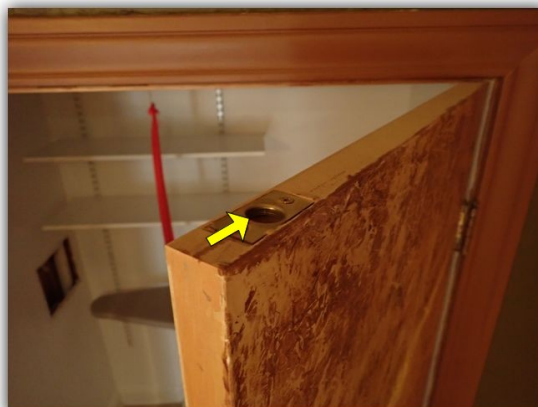
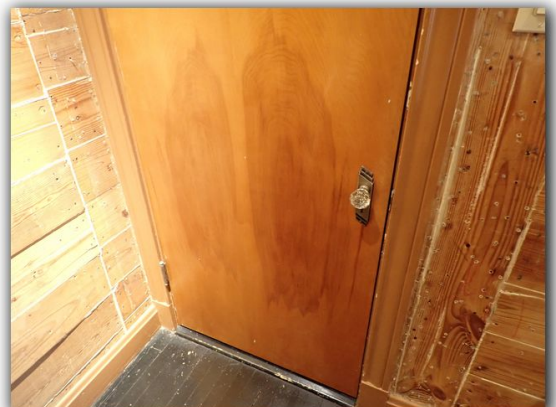
- The door(s) are not latching properly and/or sticking in front corner bedroom and front corner bedroom closet, master bedroom. Recommend minor adjustments to the jams, hinges and/or striker plates as needed.
- One or more of the interior doors are out of square and have been shaven at the top to help them fit the opening. This may be due to adverse foundation performance.
- The door hardware is missing to the bedroom hallway closet, side middle bedroom closet.

- The door hardware is missing to the apartment entry door.
- Weather-stripping improvements are recommended for the apartment exterior door(s).

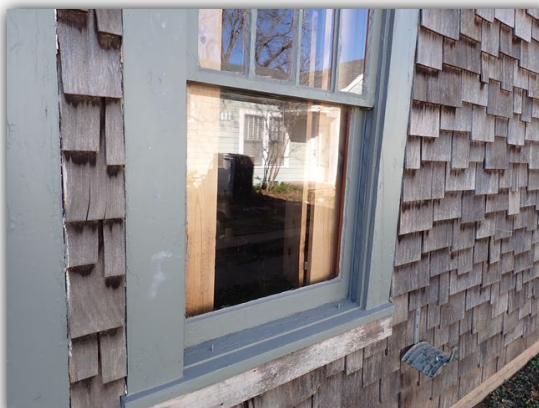
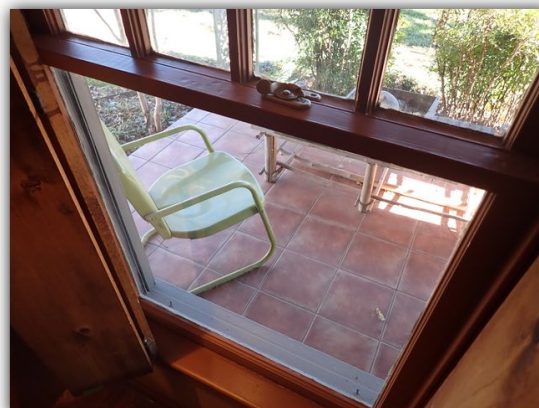
- One or more of the window screens were observed to be missing.

- **Note:** I was unable to inspect the operation of some of the windows due to window treatments, personal effects, large, heavy or fragile storage and/or furniture.
- One or more of the windows were observed to be stiff and hard to operate in the various locations throughout the house.
- Window lock(s) were observed to be loose and/or missing in the living room and dining room.
- Cracked and/or broken window glass was observed in the master bedroom and guest bedroom.

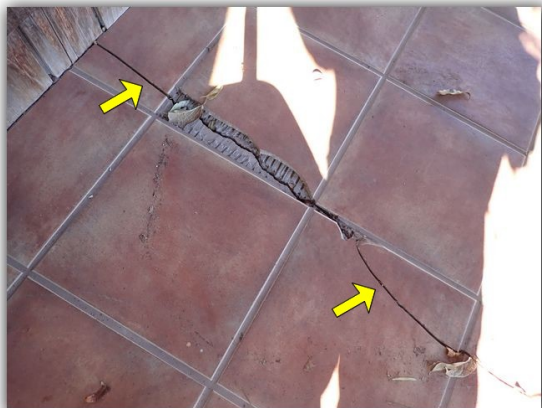
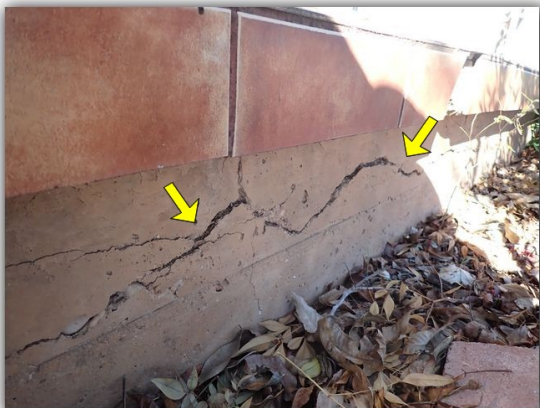
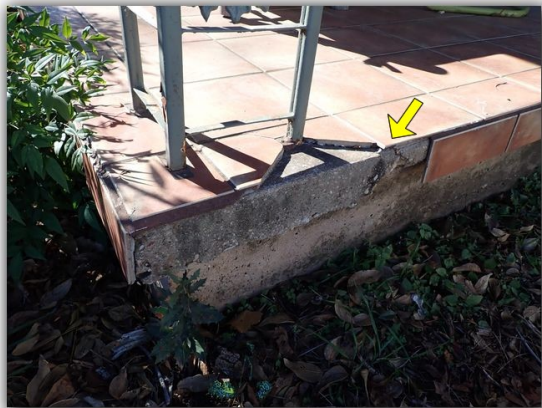
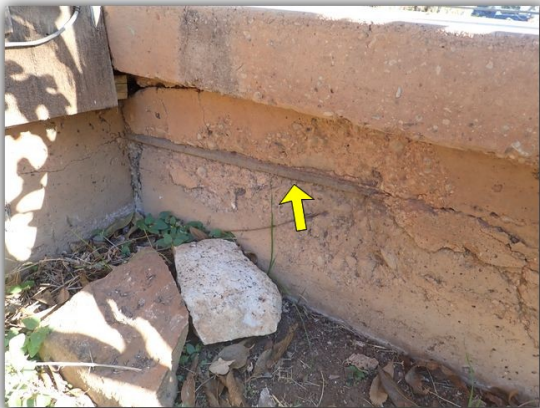
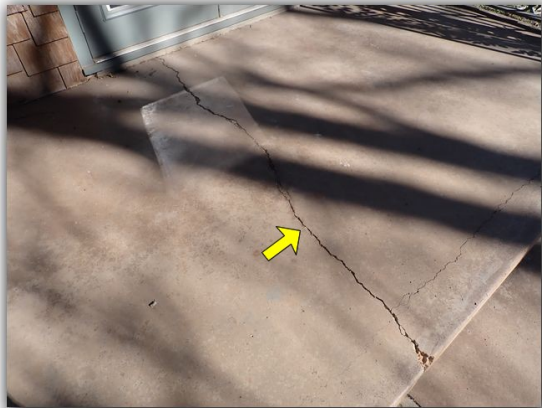
- Some deflection and/or cracking of the patio concrete flatwork was observed.
- One or more of the tiles were observed to be cracked and/or missing.
- Exposed rebar was observed at the side porch.

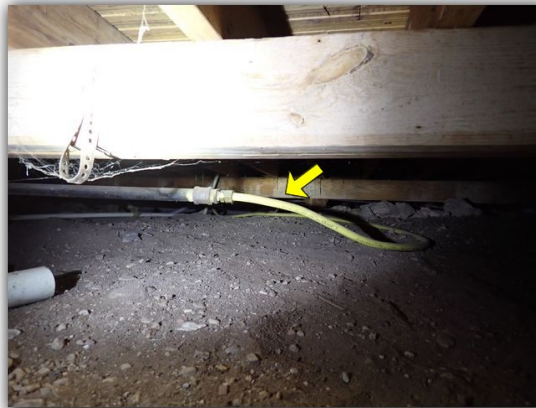
- The gas piping in this house includes corrugated stainless steel tubing (CSST). Whether or not an appropriate electrical bond between the gas piping systems and the electrical system, as (currently) required by (the manufacturer(s) / NFPA 54, The National Fuel Gas Code), could not be visually confirmed. The lack of suitable electrical bonding may increase the potential for lightning strikes to cause arcing at the CSST gas piping that may result in perforation of the piping, gas leaks, and fires. Proper adherence to the manufacturer's bonding instructions should lower the risk of electrical arcing and related damage. It is recommended that a licensed electrician further evaluate this installation, make needed corrections to the bonding system and verify proper bonding of all components as needed.

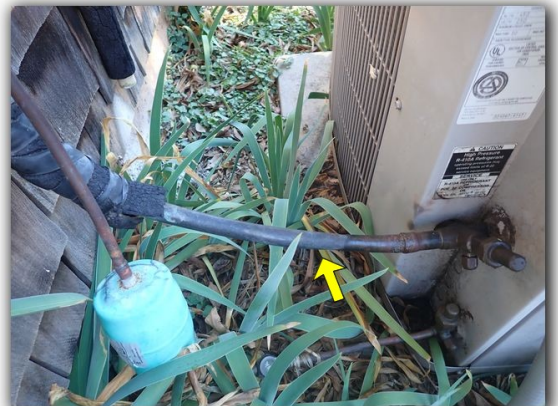
- Damaged, deteriorated and/or missing insulation on the refrigerant lines should be repaired or replaced at the outside condenser.

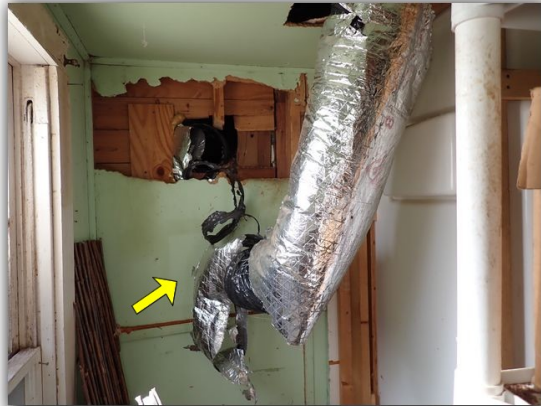
- Some of the ductwork was observed to be damaged and/or crushed in the garage area. This condition should be further evaluated and corrected as necessary.

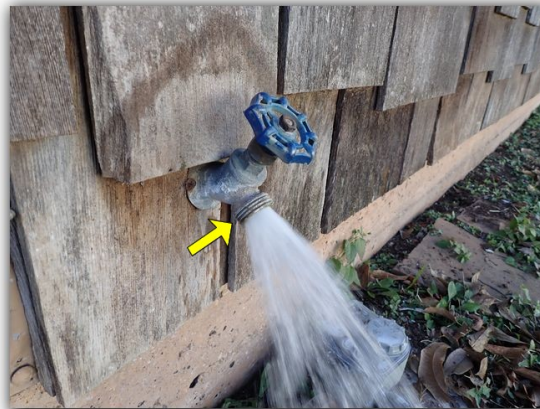
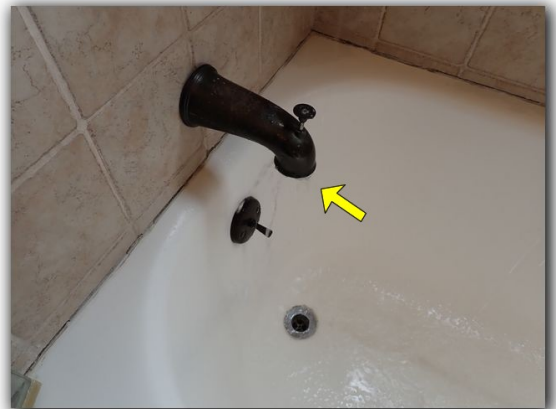
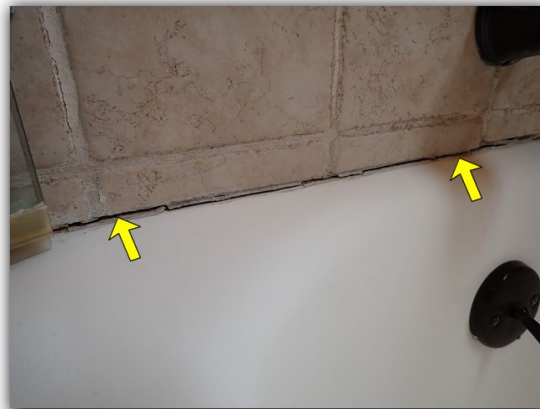
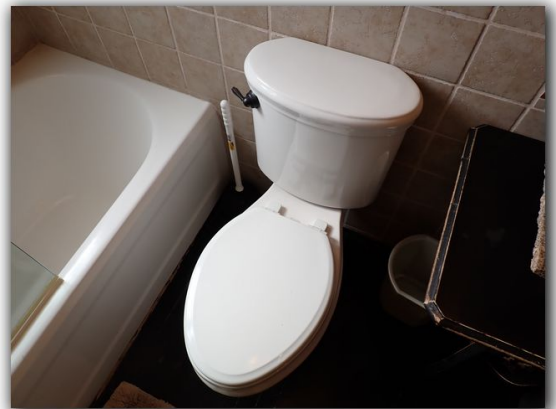
- Cracked, deteriorated and/or missing bathtub enclosure grout and/or caulking should be repaired or replaced as necessary.

- The bathtub shower diverter leaks when operated.

- The stopper is missing.
- An "S" type trap was observed to be in use. Under current building standards this type of drain trap is no longer an accepted practice.

- The commode is loose at the floor mount.

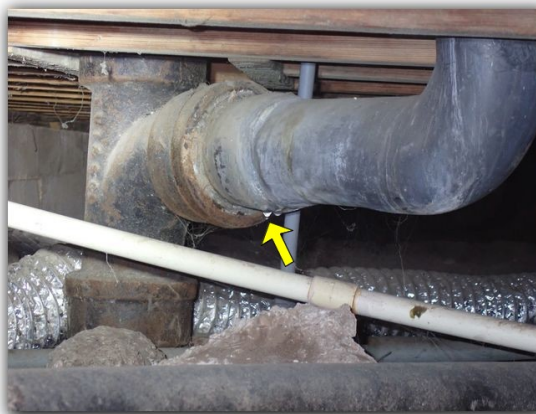
- Cast iron material was observed to be present in the drains, wastes and vents system. Full evaluation of the integrity of this type of material is beyond the scope of this inspection. Due to the known latent defects that are associated with this type of older material, it is recommended to have the integrity of the drain system further evaluated by a qualified plumber. It is recommended to have a hydrostatic test and to have the inaccessible and buried pipes scoped with a camera as part of this evaluation. This evaluation should occur prior to the expiration of any time limitations such as option or warranty periods.

- There are visible leaks in the cast iron piping system. Further evaluation of this condition is recommended.
- **Note:** While water was run down the drains, this cannot simulate the waste flows characteristics of a fully occupied structure. Unless specified, fixtures and vessels were not filled to capacity for leak testing to prevent inadvertent water damage to the property. This means that some leaks may go undetected. Comprehensive water leak testing, including hydrostatic testing, may be available from qualified, licensed plumbers. You may also consider further testing and inspection of the sewer line(s) in older homes (40+ years), homes with previous foundation repair, and homes with evidence of poor foundation performance.

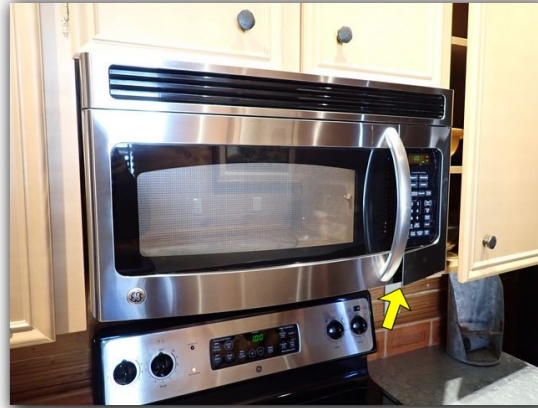
- The microwave oven surface trim is pulling loose.
