Brian Kruchkow
1509 & 1511 Yeomans Rd
Abilene, TX 79602

December 18, 2023

PROPERTY INSPECTION REPORT FORM

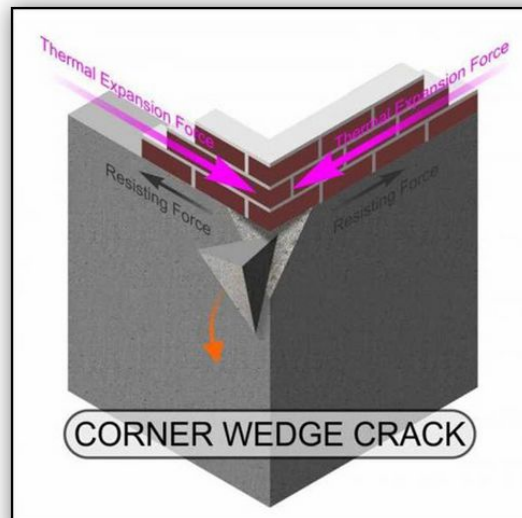
- One or more of the foundation perimeter beam corners were observed to be sheared off (corner pop). This is a common condition to observe and is do to thermal expansion and contraction of the different building materials. This condition does not adversely affect the foundation performance. However, in some cases, some cosmetic improvements may be necessary.

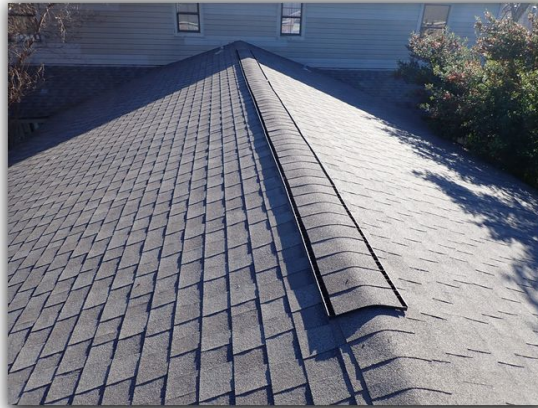
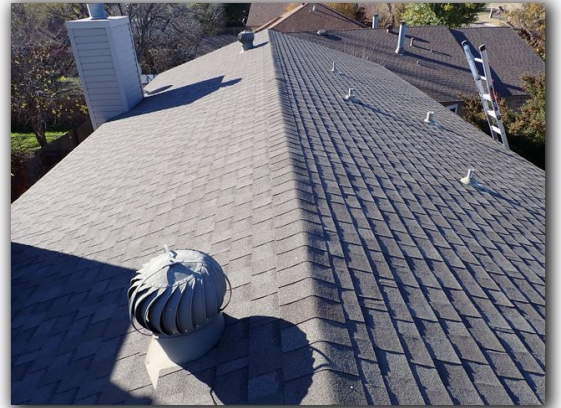
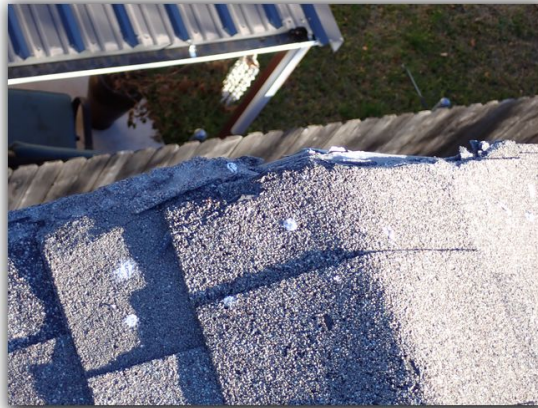
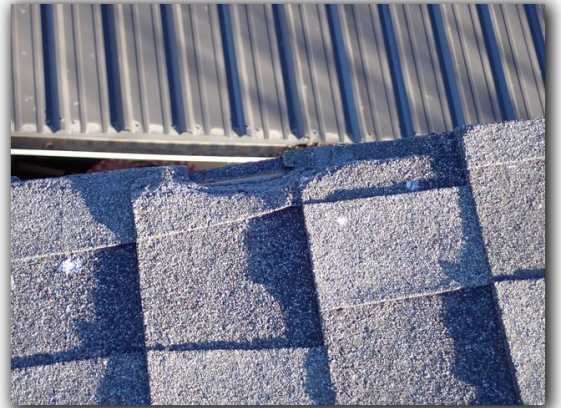
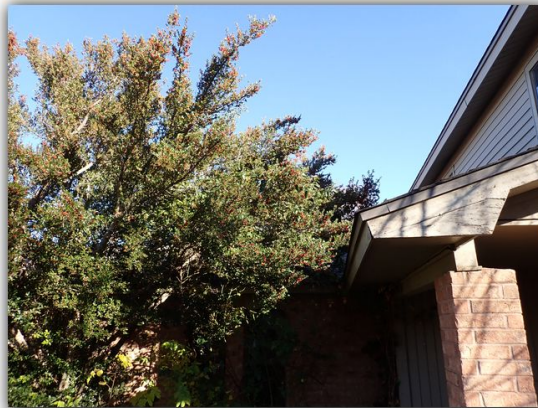
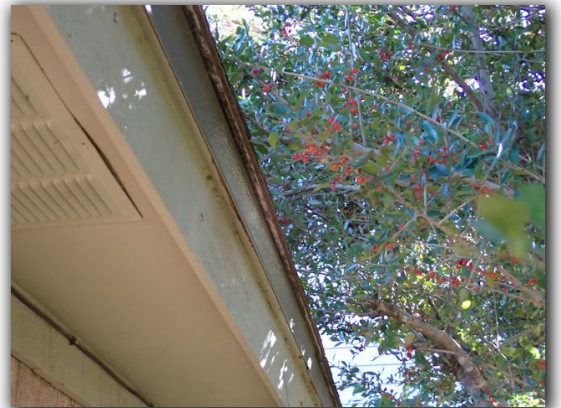
- Damaged shingles were observed on the east side of the roof structure.
- Tree and shrub branches need to be trimmed away from the roofing material at all times to help prevent damage to the roofing material. It is the opinion of this Inspector that there are some branches too close to the roofing material at this time and corrective measures are needed.

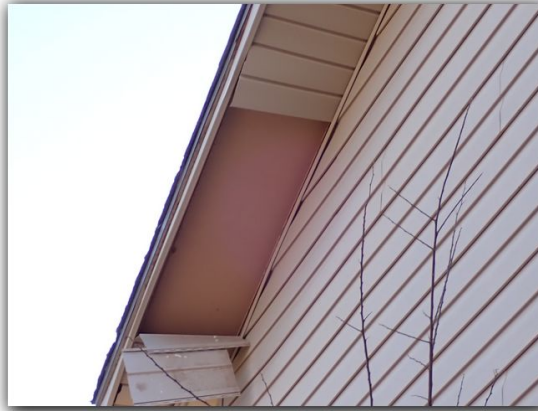
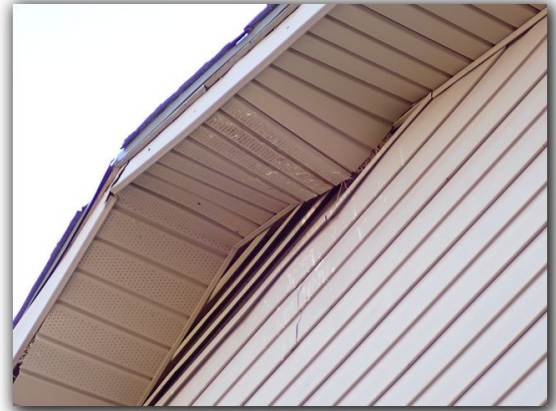
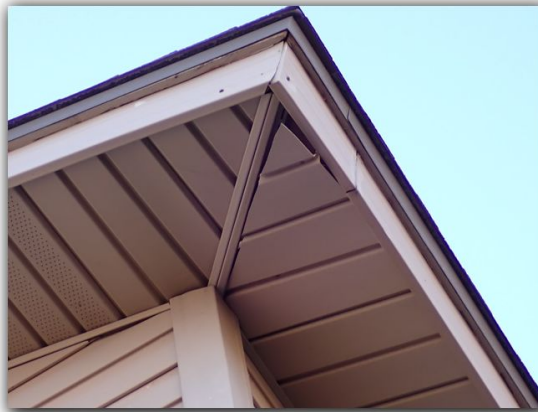
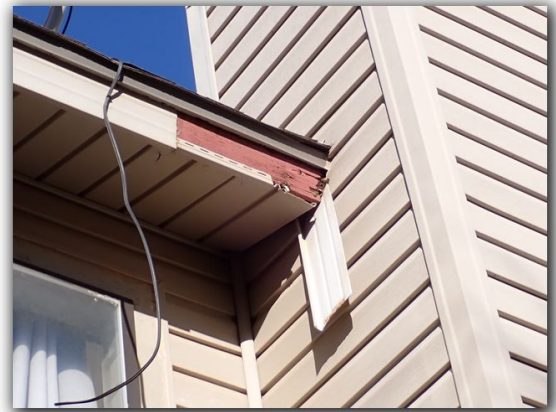
Roof Structure

- The fascia board material has some deterioration and/or damage on the east and south sides of the roof structure.
- The soffit material has some deterioration and/or damage on the east side of the roof structure.
- The soffit material is sagging and/or pulling loose on the north side of the roof structure.

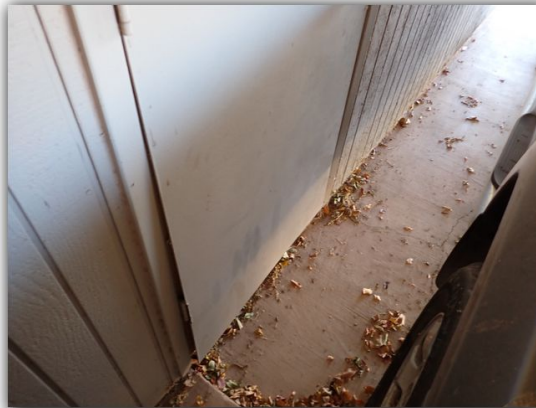
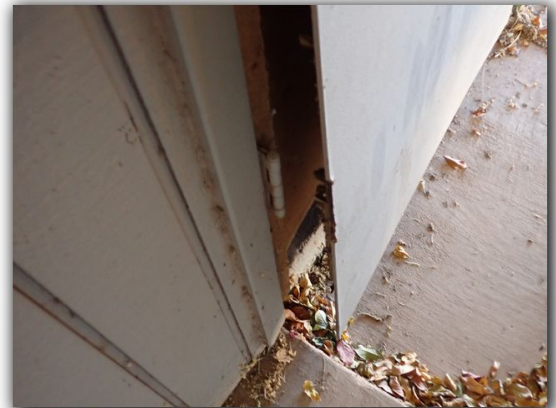
- The hollow core door is separating and/or damaged to 1511 carport.

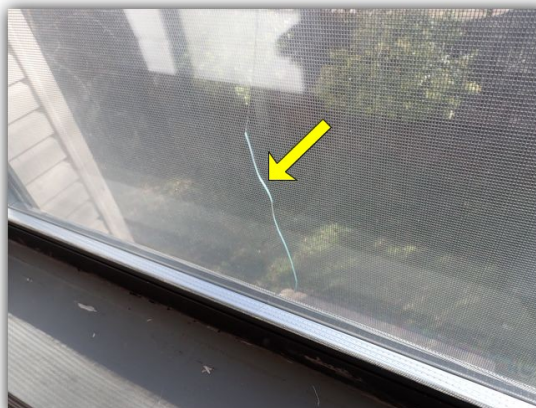
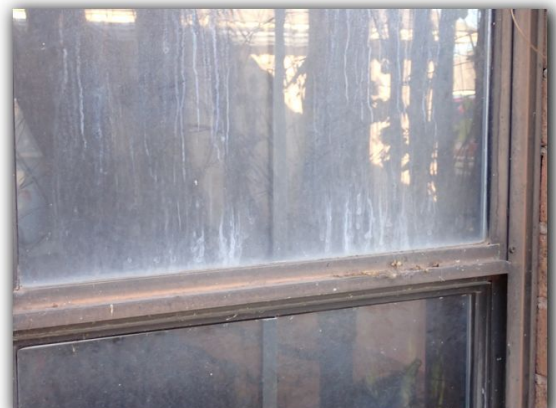
- One or more of the window screens were observed to be damaged.
- One or more of the window screens were observed to be missing.

- **Note:** I was unable to inspect the operation of some of the windows due to window treatments, personal effects, large, heavy or fragile storage and/or furniture.
- Cracked and/or broken window glass was observed in the 1509 upstairs bedroom.
- One or more of the thermal pane windows were observed to have lost their seals. This has resulted in condensation or a fog like film to develop between the panes of glass. The thermal pane windows no longer function as designed when they lose their seal and replacement may be necessary. The windows that have noticeably lost their seals are listed but may not be limited to the following:
1509 downstairs bedroom, 1511 downstairs bedroom, 1509 living area, 1511 living area.
(Total 8)

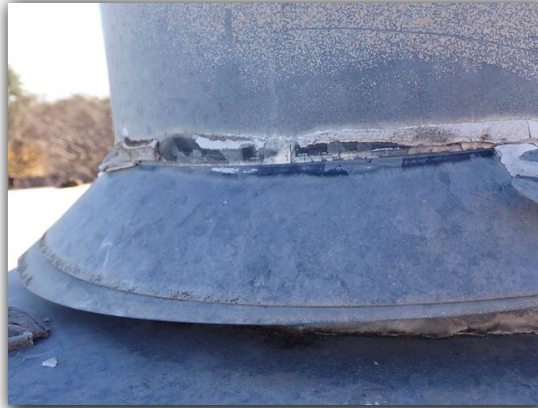
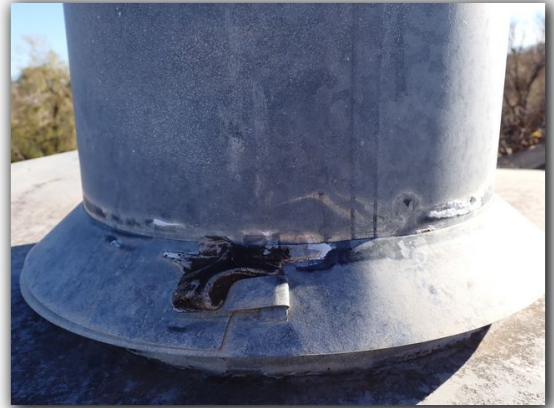
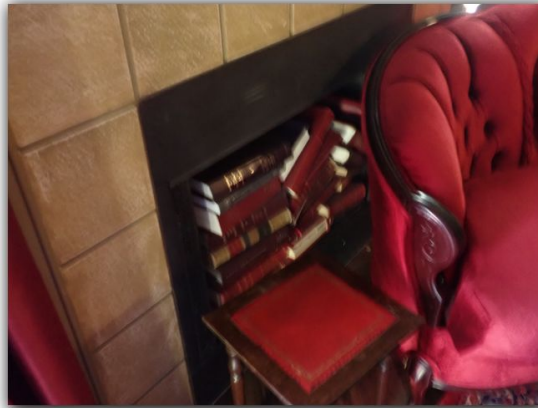
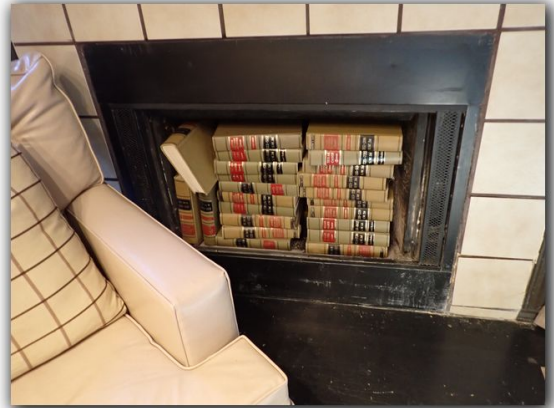
- Both of the roof level flue storm collars need to be properly sealed to help prevent water intrusion into the structure.
- **Note:** I was unable to gain access and inspect both fireboxes and lower flue areas. If the fireplaces are to be used in the future it is highly recommended they be inspected and possibly cleaned prior to use.

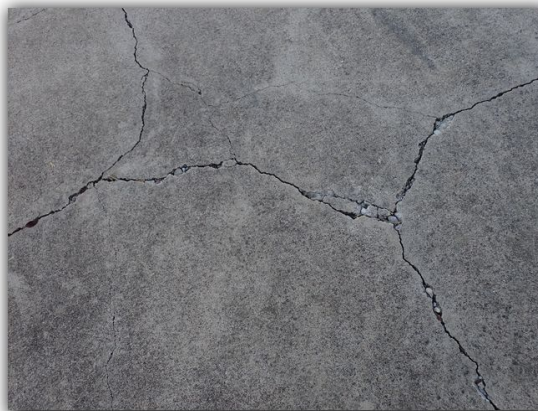
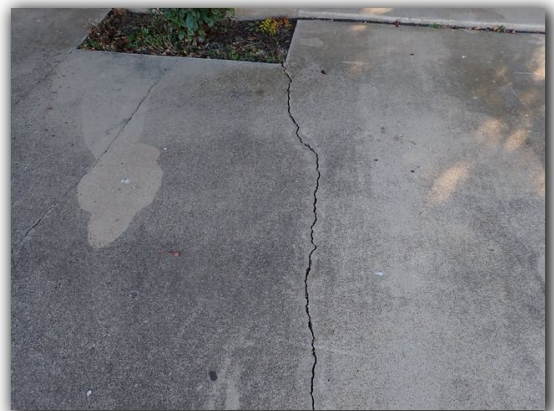
Driveway

- Cracks and/or deficiencies were observed in the driveway.

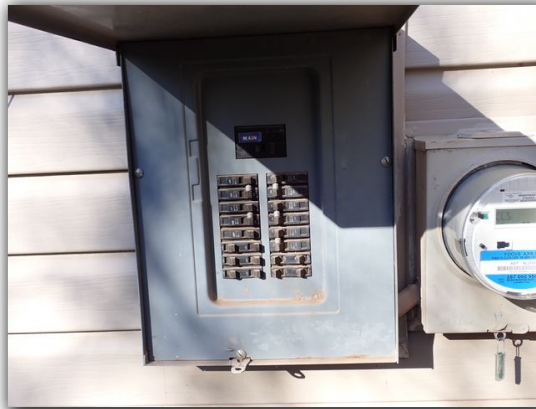
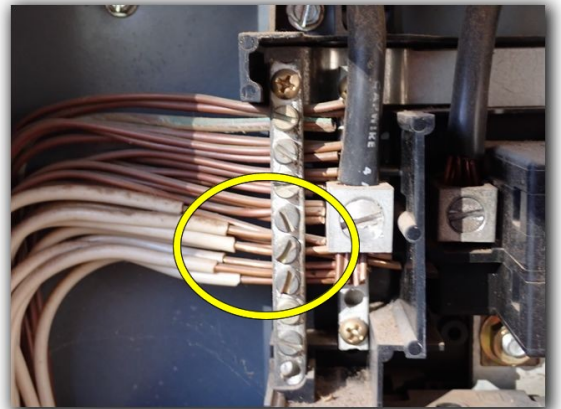
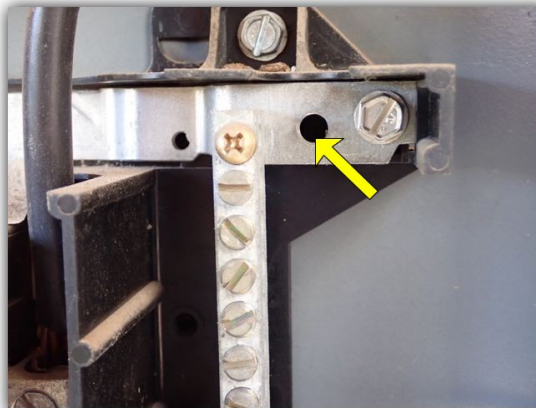
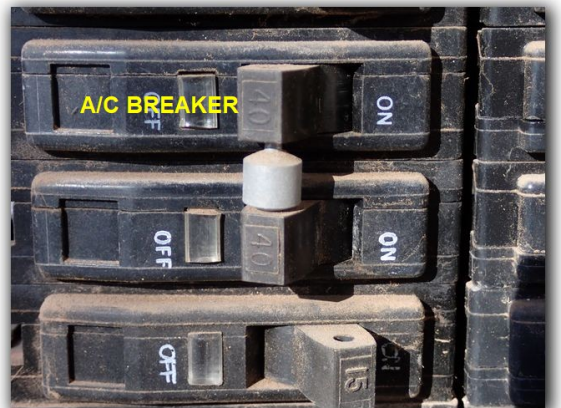
- The electrical cabinet does not appear to be properly bonded to the electrical system.
- There are multiple neutral wires secured under one lug/screw on the neutral bus bar. This type of installation does not meet current electrical standards. These conditions may not have violated building codes or common practices at the time of the construction of the home, or they may have been **“grandfathered”** because they were present prior to the adoption of codes prohibiting such conditions.
- The manufacturers listing plate on the Central Cool System outside condenser/coil list that the maximum over current device (breaker) to be used should not exceed 30-amp. There is a 40-amp breaker in place at this time. This breaker in place does not meet the manufacturers listing plate requirements.

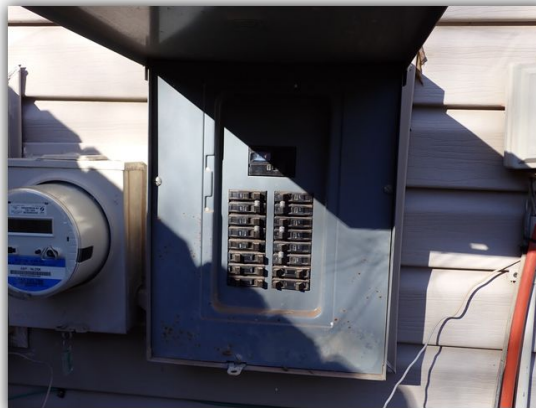
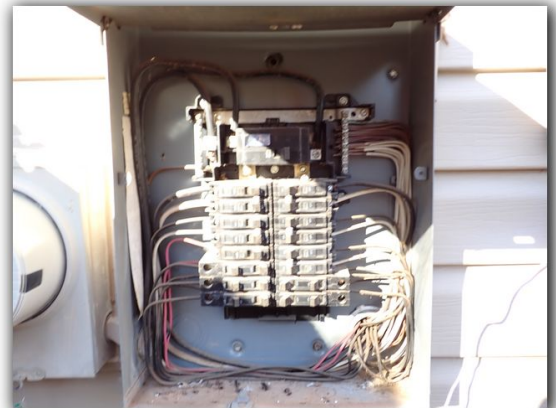
1511 Panel Box

- The electrical cabinet does not appear to be properly bonded to the electrical system.
- There are multiple neutral wires secured under one lug/screw on the neutral bus bar. This type of installation does not meet current electrical standards. These conditions may not have violated building codes or common practices at the time of the construction of the home, or they may have been “grandfathered” because they were present prior to the adoption of codes prohibiting such conditions.
- The manufacturers listing plate on the Central Cool System outside condenser/coil list that the maximum over current device (breaker) to be used should not exceed 30-amp. There is a 40-amp breaker in place at this time. This breaker in place does not meet the manufacturers listing plate requirements.

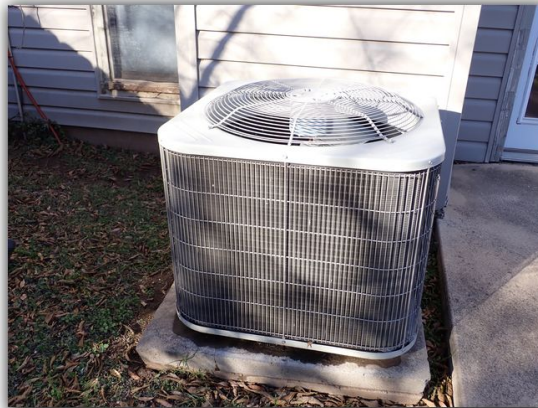
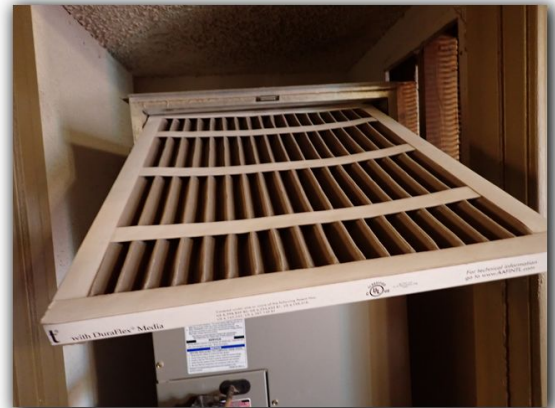
Type of System: **1509 Cooling System**

- The dirty air filter should be replaced.

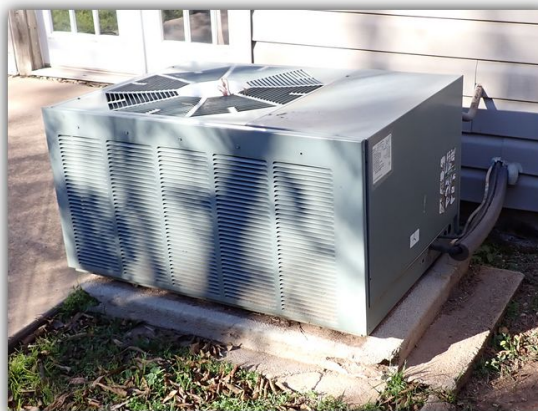
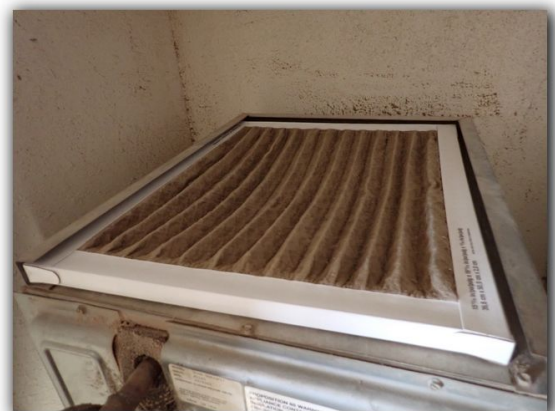
Type of System: 1511 Cooling System

- The dirty air filter should be replaced.

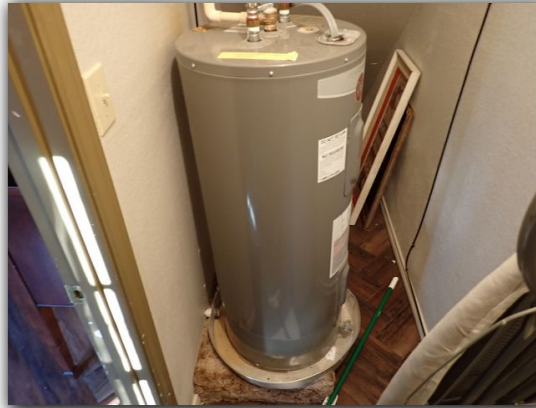
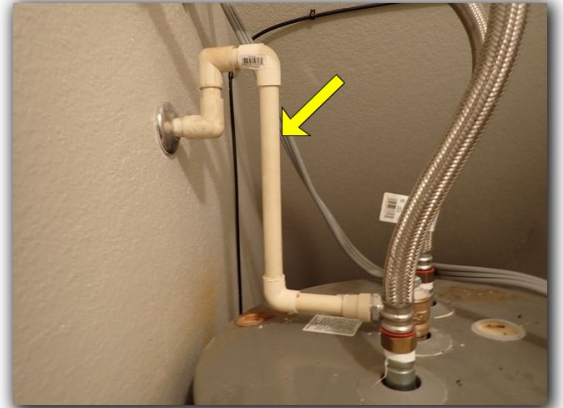
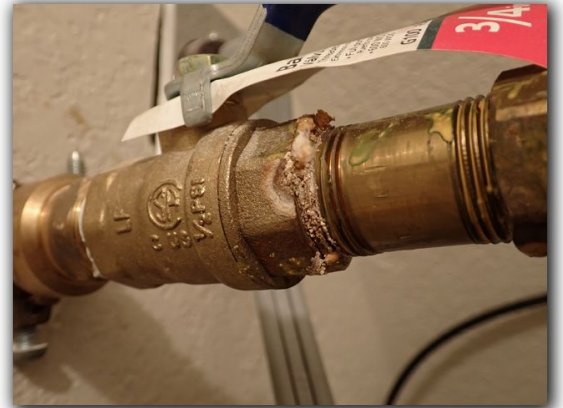
- Some corrosion was observed on the water supply shutoff valve.
- The temperature and pressure relief (TPR) valve discharge pipe is running in an upwards direction in one or more locations. The TPR discharge pipe should run gravitationally downwards at all points.

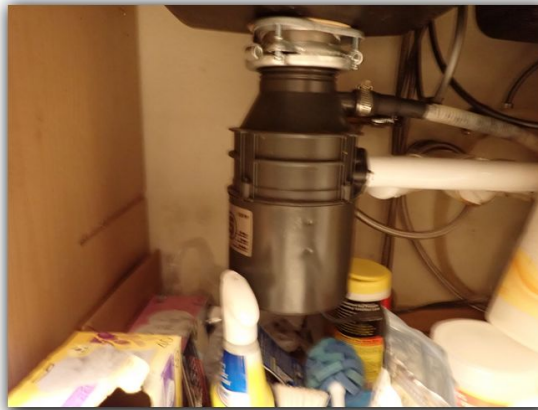
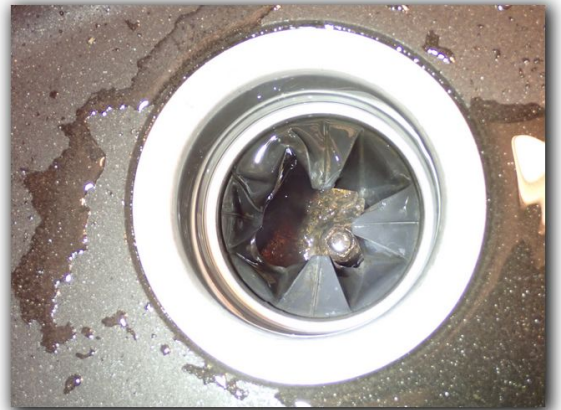
B. Food Waste Disposers

- The splashguard for the food waste disposer is damaged and/or missing.
