Brian Kruchkow
1918 S 9th St
Abilene, TX 79602

December 18, 2023

PROPERTY INSPECTION REPORT FORM

Brian Kruchkow <i>Name of Client</i>	12/18/2023 <i>Date of Inspection</i>
1918 S 9th St, Abilene, TX 79602 <i>Address of Inspected Property</i>	
David Renner <i>Name of Inspector</i>	20502 / NAWT #12181ITC <i>TREC License #</i>

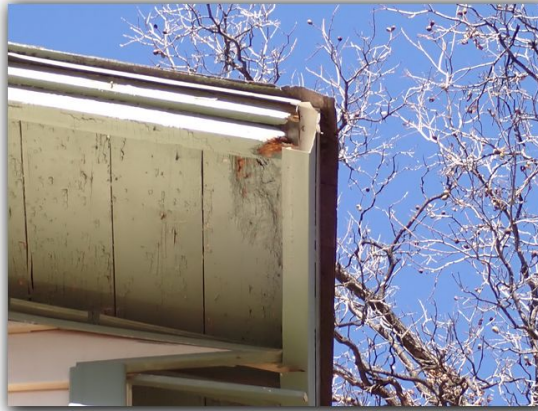
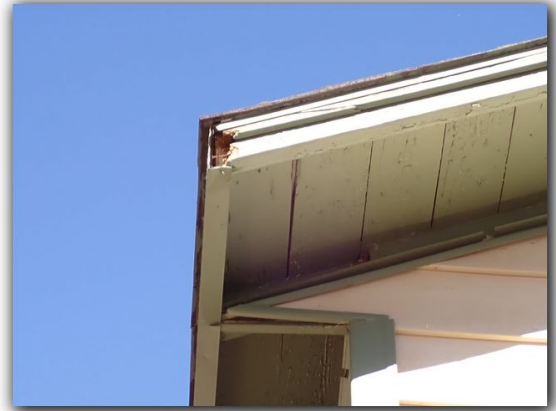
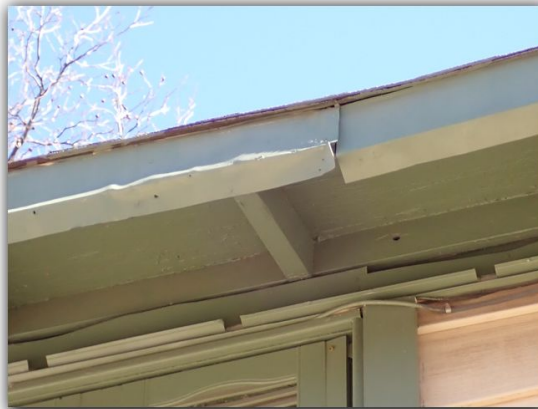
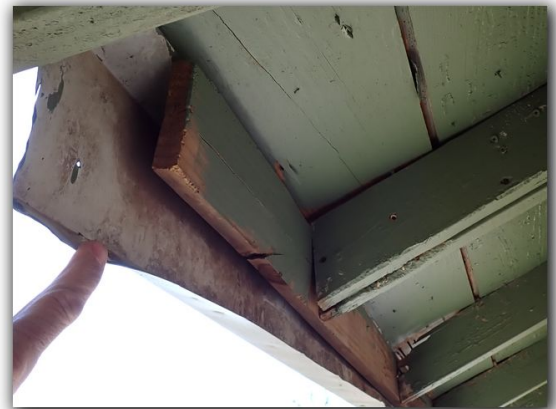
Roof Structure

- The fascia board material has some deterioration and/or damage on the north, east, west and south sides of the roof structure.
- Some roof sheathing (decking) deterioration and/or damage was observed in one or more locations.

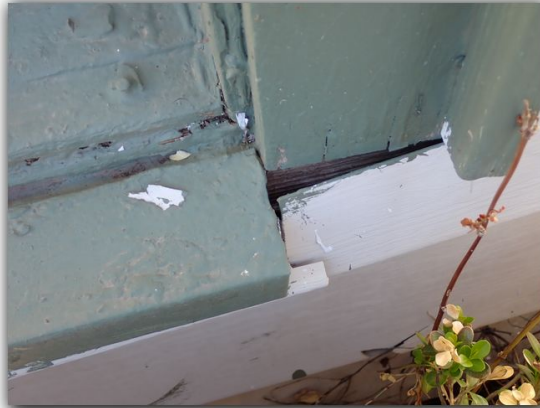
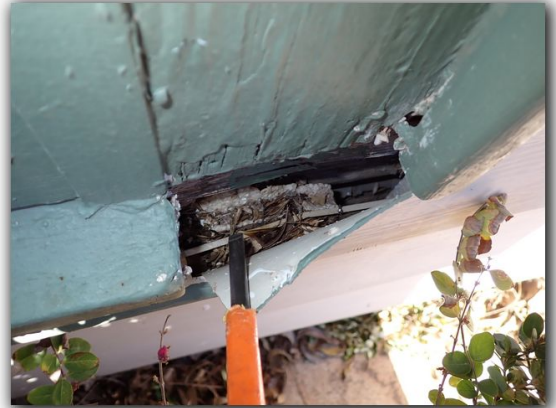
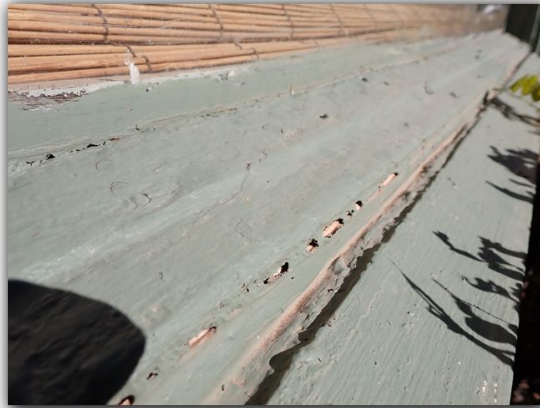
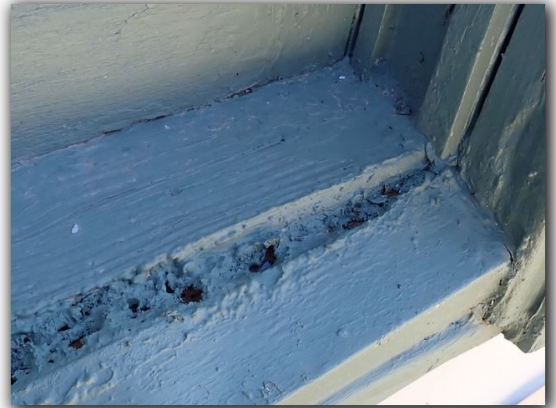
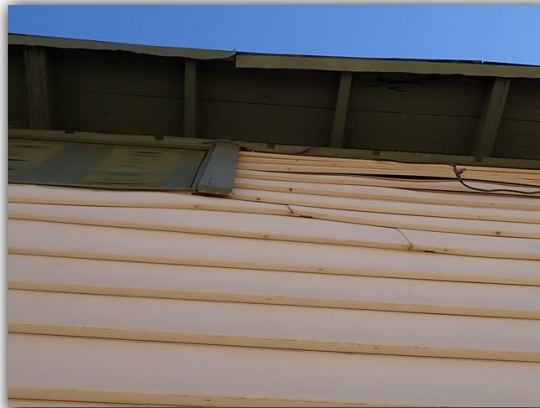
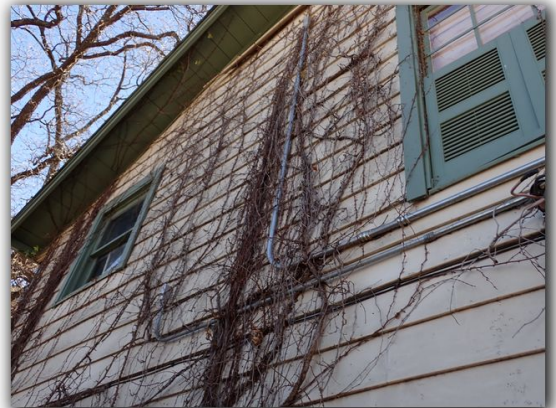
- The exterior wood window casing has some deterioration and/or damage on the north, east, west and south sides of the structure.
- The vinyl siding was observed to be damaged on the north, east, west and south sides of the structure.
- The exterior veneer / cladding was observed to be pulling loose and needs to be better secured on the north side of the structure.
- Some of the exterior wood type surfaces need a fresh coat of paint.

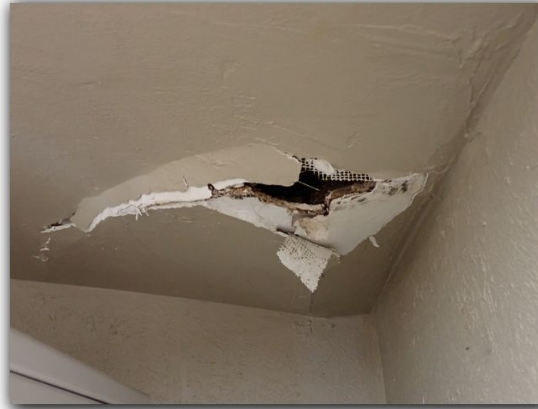
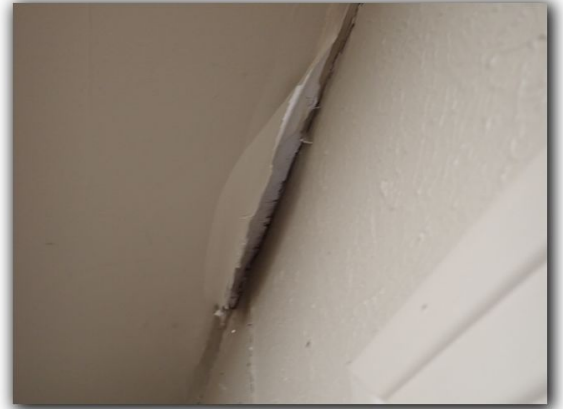
- **Note:** There is evidence of painting and patching to the interior finish and prior interior finish repairs. This condition could limit the Inspectors visual observations and ability to render accurate opinions as to the performance of the structure.
- The ceiling was observed to be damaged in the laundry room.

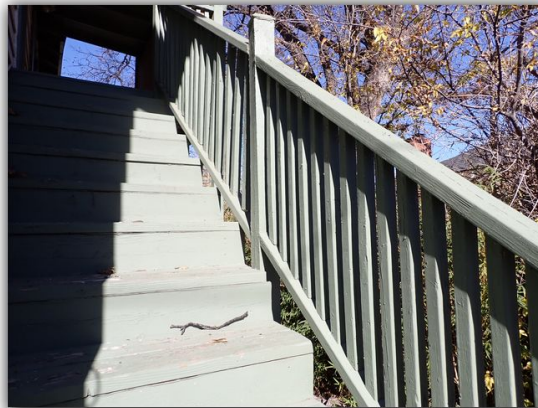
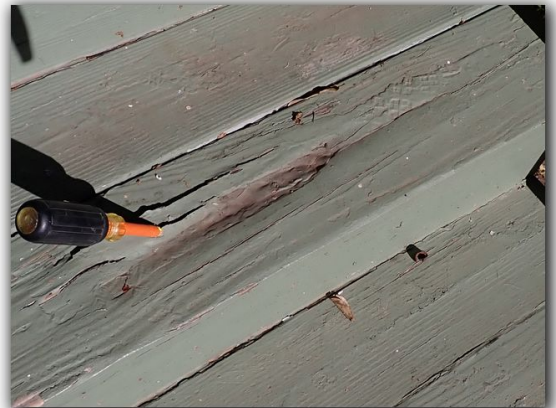
- The railing and/or guardrail for the stairway is loose and should be better secured for reasons of safety.
- One or more of the spindles and/or balusters were observed to be damaged
- Some of the steps are in poor condition and repairs are needed for reasons of safety.

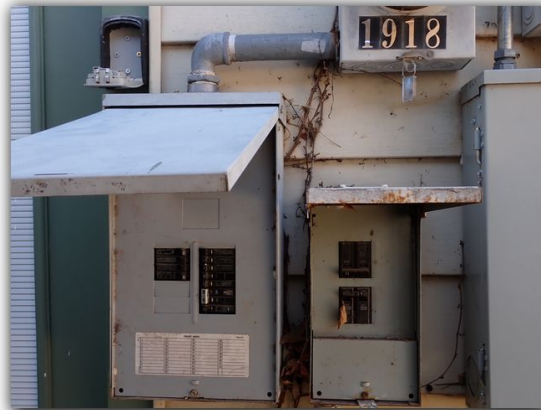
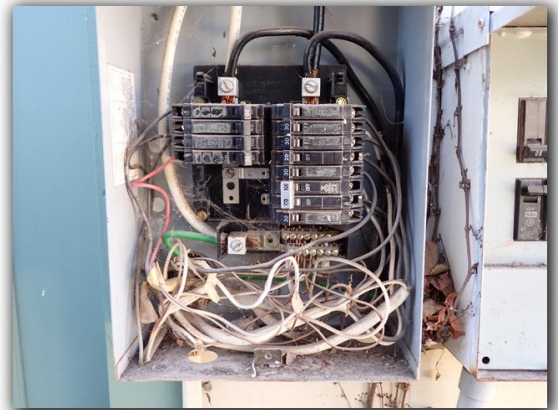
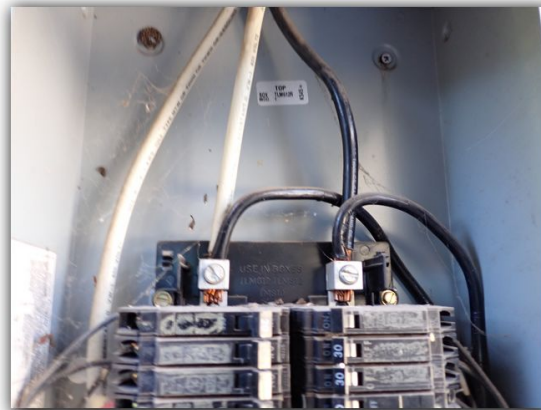
- The breakers (overcurrent devices) in the electrical panel are not properly labeled.
- There was no main disconnect observed in the panel box. This may be an “as-built” condition but *Per TREC standards of practice we are required to report this condition as a deficiency.*
- The main terminal lugs are double lugged.
- One or more of the cabinet cover plate screws are missing and need to be replaced.

The electrical system should be checked by a Qualified Licensed Electrician. The observations made to support the rendering of this opinion are listed but not limited to the following:

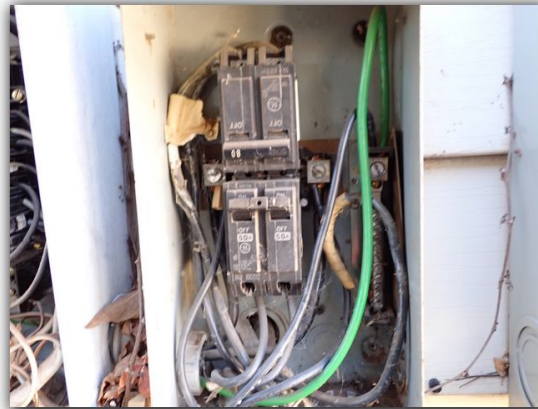
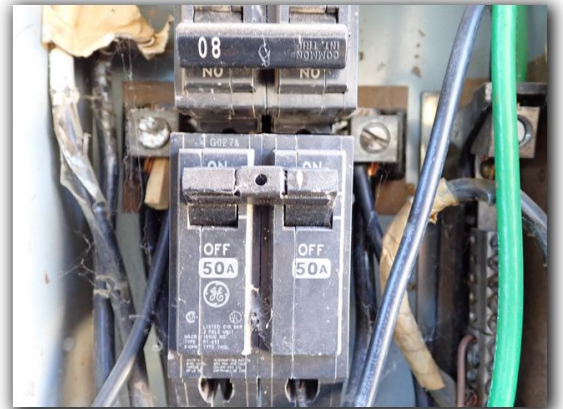
- The breakers (overcurrent devices) in the electrical panel are not properly labeled.
- There was no main disconnect observed in the panel box. This may be an “as-built” condition but *Per TREC standards of practice we are required to report this condition as a deficiency.*
- The electrical cabinet does not appear to be properly bonded to the electrical system.
- The main terminal lugs are double lugged.

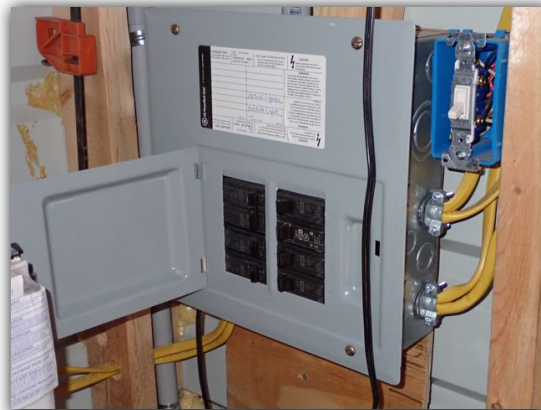
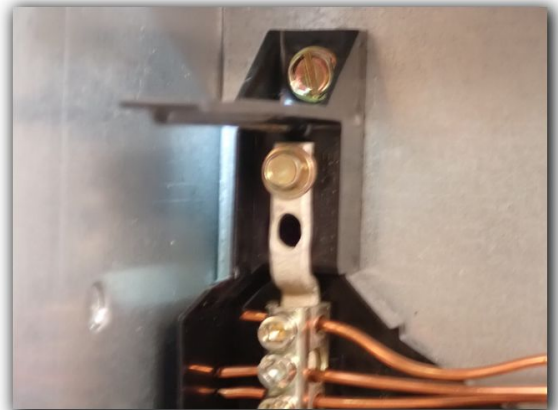
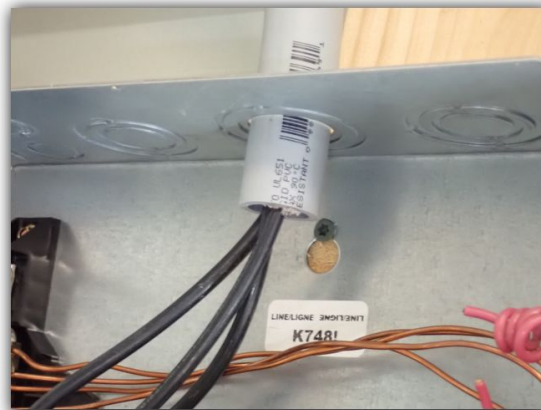
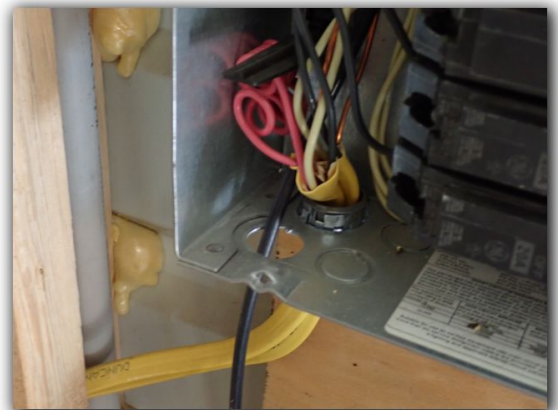
- The breakers (overcurrent devices) in the electrical panel are not properly labeled.
- There was no main disconnect observed in the panel box. This may be an “as-built” condition but *Per TREC standards of practice we are required to report this condition as a deficiency.*
- This panel is fed via the smaller GE panel on the main structure. There is no service disconnect for the wiring from the GE panel to this panel in the out building. This condition basically has the service entrance wiring run in poorly designed/installed conduit in an unmarked location that has no disconnect means from the alley utility pole transformer and this electrical panel. In this inspector's opinion this needs to be corrected for reasons of safety.
- The electrical cabinet does not appear to be properly bonded to the electrical system.

Note: When D (**D=Deficient**) is marked. It is recommended that this item be fully investigated by a Qualified Licensed Electrician, prior to the expiration of any time limitations such as option or warranty periods, to fully evaluate the integrity of the entire electrical system.

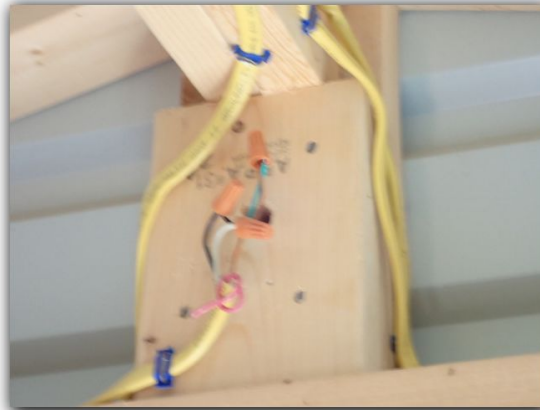
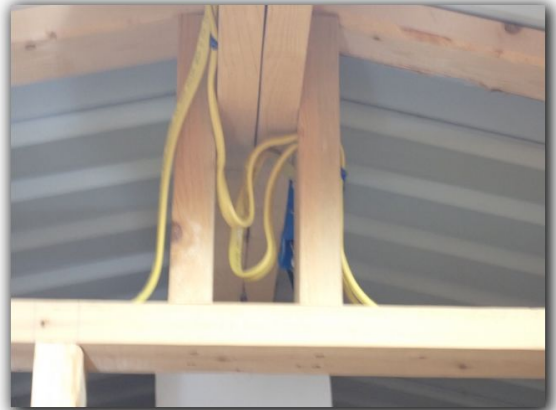
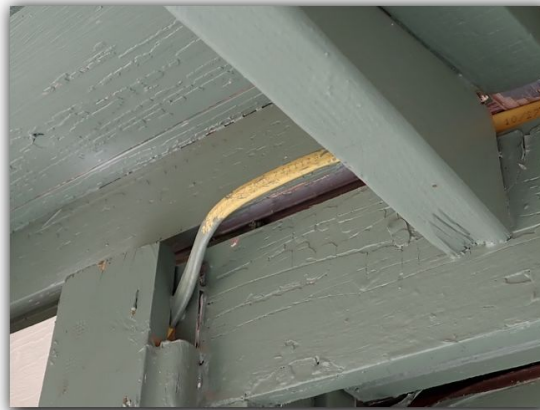
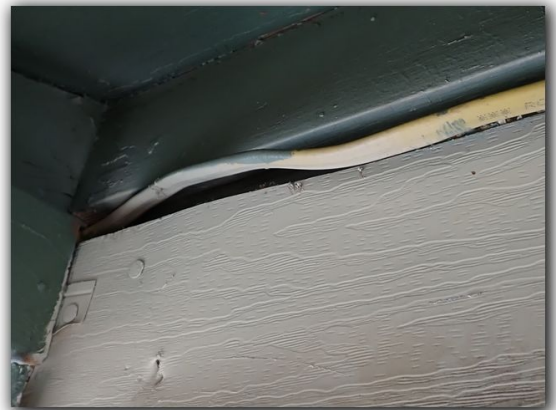
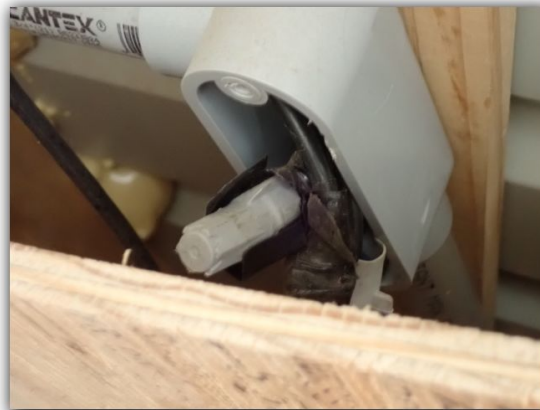
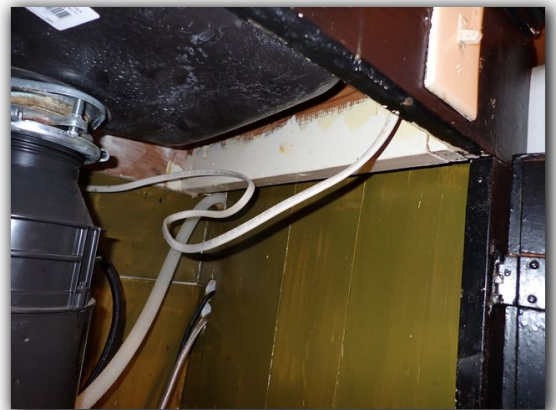
Distribution Wiring

- All exposed romex type wiring in the downstairs kitchen sink cabinet and outbuilding areas should be properly enclosed in conduit.
- Wires exposed to the outside elements (i.e. outside weather conditions) should be protected by ridged conduit. There are exposed wires located on the east side of the structure.

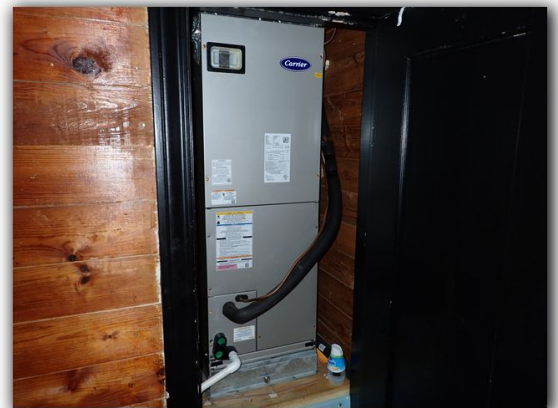
- The emergency heating equipment appears to be inoperative at the time of the inspection.

Note: When D (**D = Deficient**) is checked, it is recommended that this item be fully investigated by a Qualified / Licensed HVAC Technician, prior to the expiration of any time limitations such as option or warranty periods, to fully evaluate the integrity of the equipment.

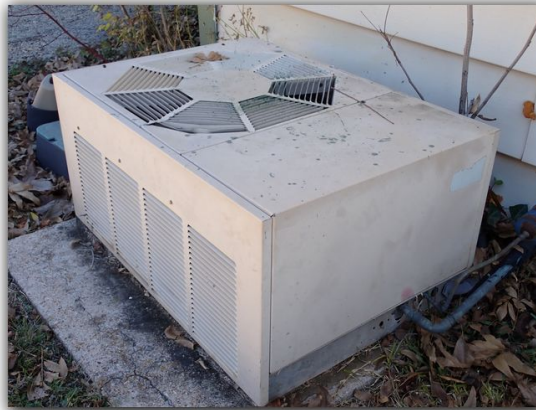
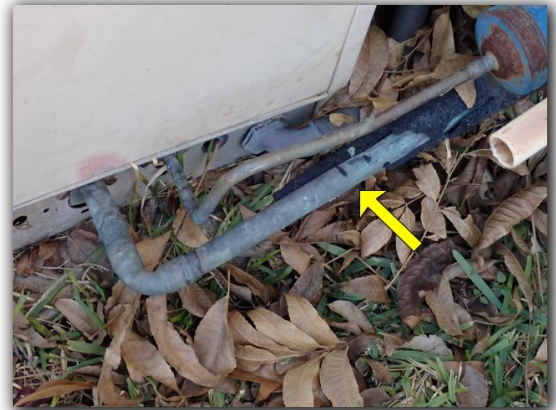
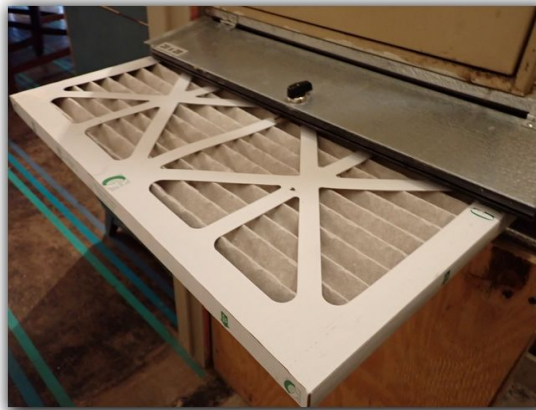
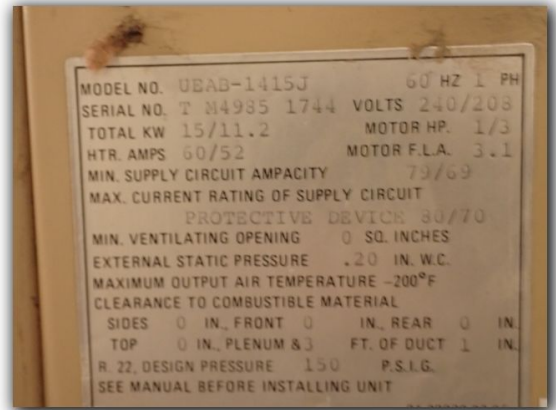
- Damaged, deteriorated and/or missing insulation on the refrigerant lines should be repaired or replaced at the outside condenser.
- The outside condenser/coil does not appear to have proper clearance above the finish grade (ground). The outside unit should have a minimum of 3-inches of clearance above finish grade (ground). This condition should be corrected to help prevent damage to the unit.

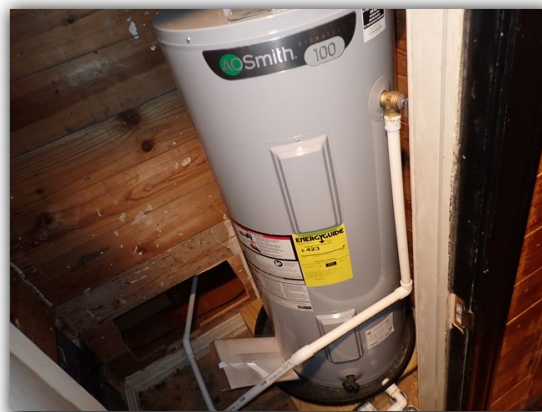
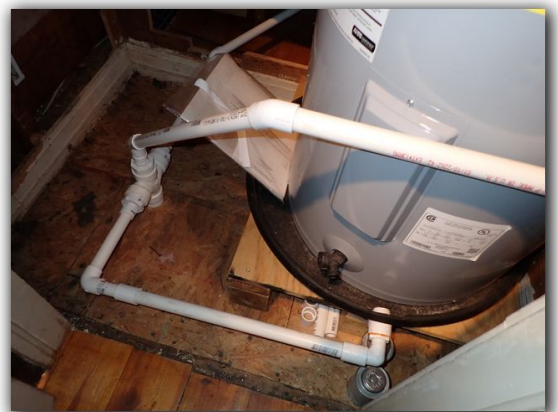
- The plastic tubing / piping being used for the temperature and pressure relief (TPR) valve discharge pipe is not listed nor labeled for this type of use.
- The temperature and pressure relief (TPR) valve discharge pipe is connected to the pan discharge pipe. This condition does not meet current mechanical installation standards. This is an “as-built” condition but Per TREC standards of practice we are required to report this condition as a deficiency.
- There was no electrical disconnect observed for the water heater.

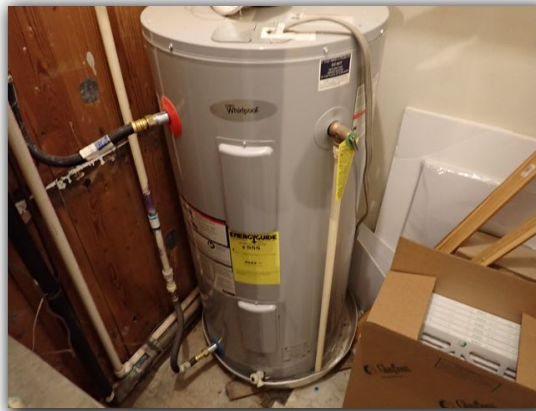
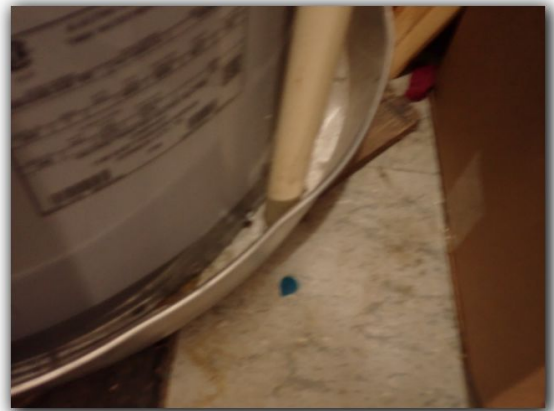
- The temperature and pressure relief discharge pipe is terminating into the water heater drain pan. Under current building standards, this discharge pipe should run downward to the exterior of the structure, turn downward, and terminate within 6-inches of the ground.
- There is no drain line installed for the water heater pan. The pan should have a drain line installed that should terminate over a suitably located indirect waste receptor or shall extend to the exterior of the building and terminate not less than six-inches (6”) and not more than twenty-four inches (24”) above of the ground.

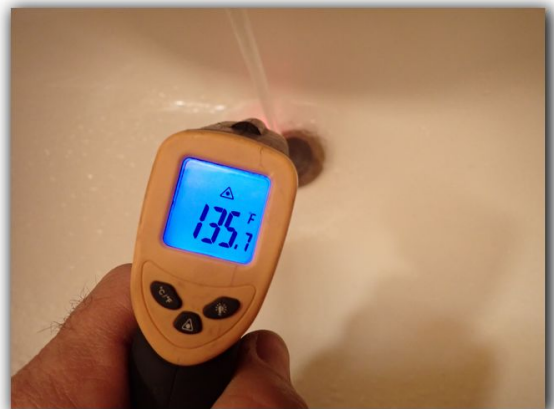
- **Note:** The water heaters are set to a high temperature. Recommend lowering to reduce the risk of severe burns.

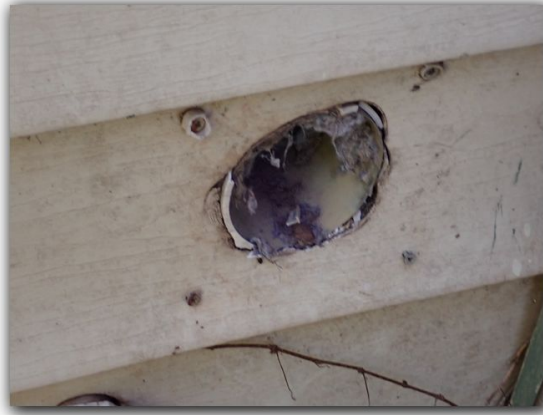
- The exterior dryer duct termination cover is missing.
