Brian Kruchkow
942 Amarillo St
Abilene, TX 79602

December 18, 2023

PROPERTY INSPECTION REPORT FORM

Brian Kruchkow <i>Name of Client</i>	12/18/2023 <i>Date of Inspection</i>
942 Amarillo St, Abilene, TX 79602 <i>Address of Inspected Property</i>	
Felipe Cruz <i>Name of Inspector</i>	22478 <i>TREC License #</i>

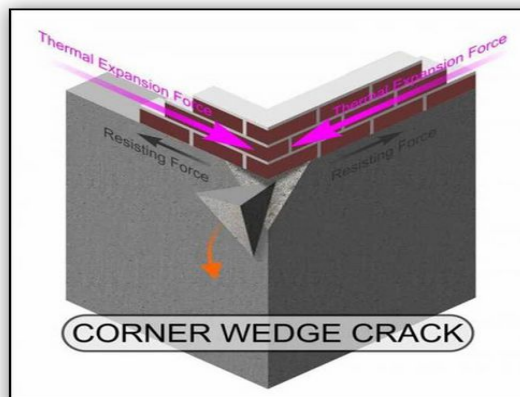
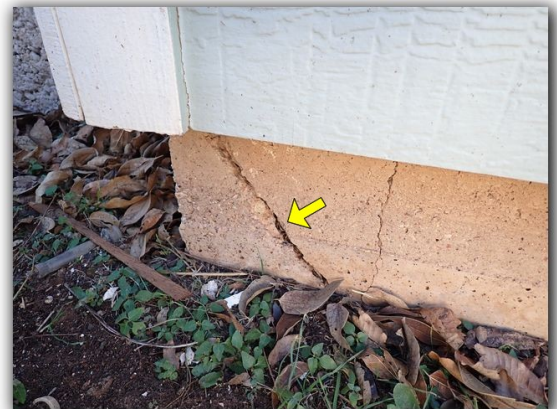
- One or more of the foundation perimeter beam corners were observed to be sheared off (corner pop). This is a common condition to observe and is do to thermal expansion and contraction of the different building materials. This condition does not adversely affect the foundation performance. However, in some cases, some cosmetic improvements may be necessary.
- **Note:** Tree(s) in close proximity of the foundation was observed. Client should consider the installation of a root barrier to reduce the possibility of damage to the foundation from tree roots and moisture removal.

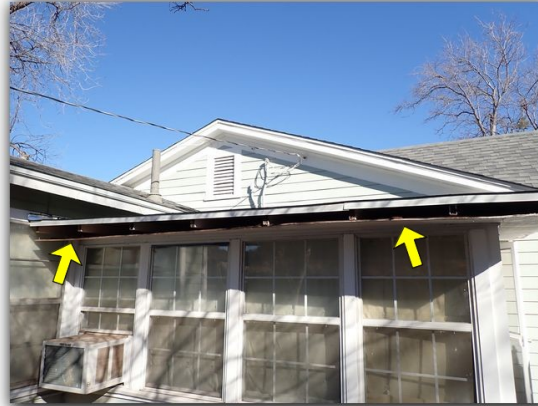
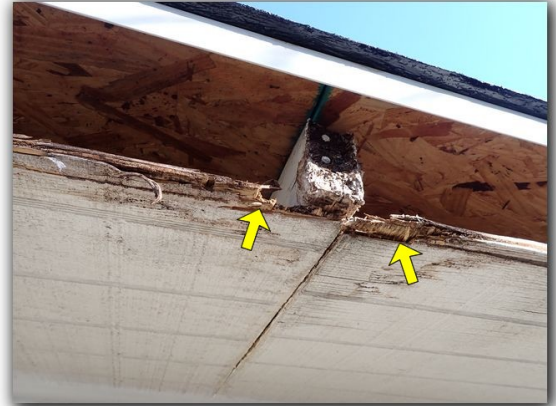
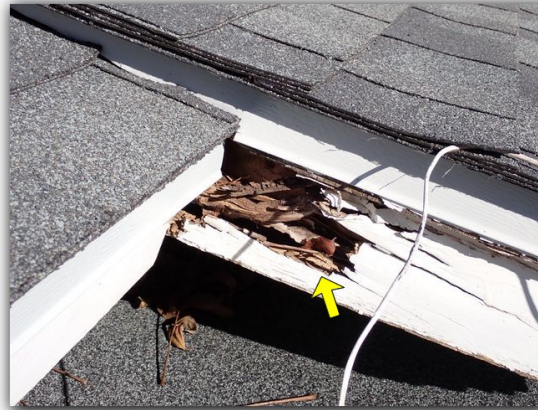
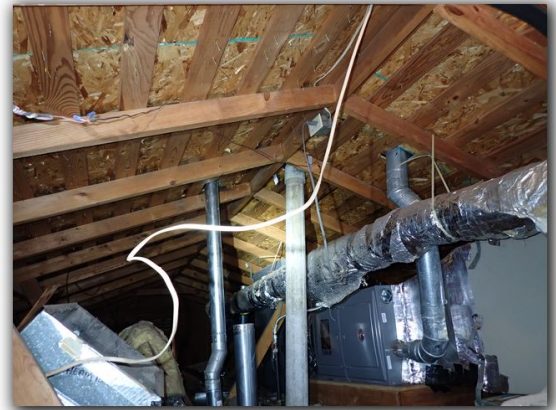
- The soffit material is sagging and/or pulling loose on the north side of the roof structure.
- The soffit material has some deterioration and/or damage on the north side of the roof structure.
- The fascia board material has some deterioration and/or damage on the west side of the roof structure.

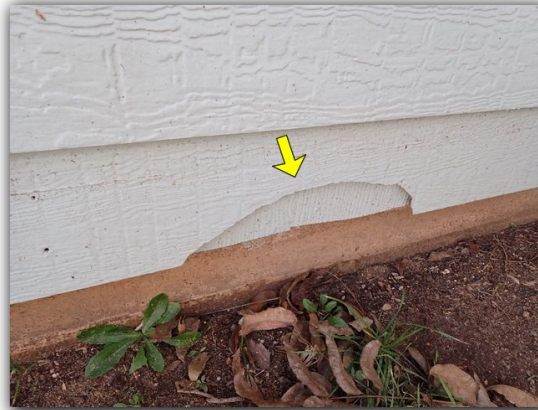
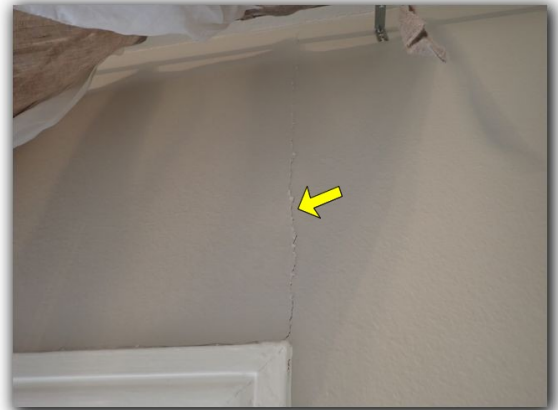
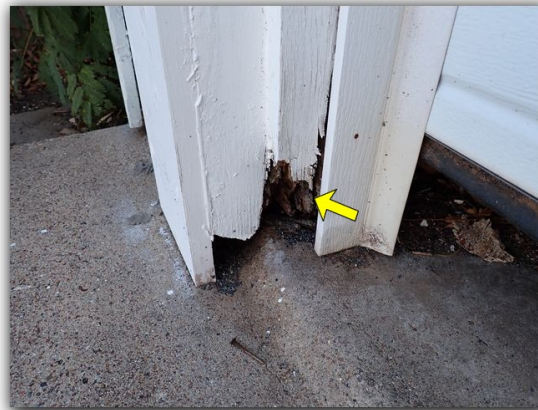
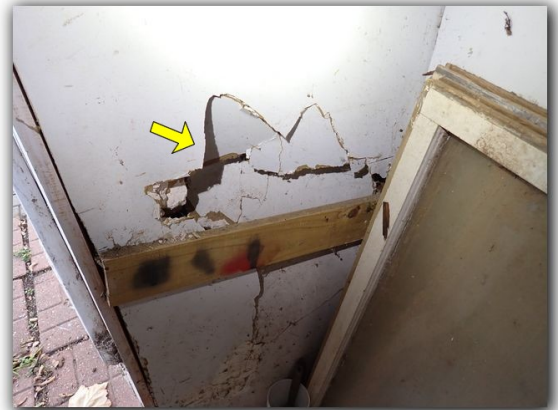
- **Note:** There is evidence of painting and patching to the interior finish and prior interior finish repairs. This condition could limit the Inspectors visual observations and ability to render accurate opinions as to the performance of the structure.
- Typical interior wall stress and/or joint cracks were observed in the garage and side middle bedroom.
- Wall surface damage was observed in the garage.

- The fiber cement board was observed to be damaged on the north side of the structure.
- The garage door trim has some deterioration and/or damage at the bottom.

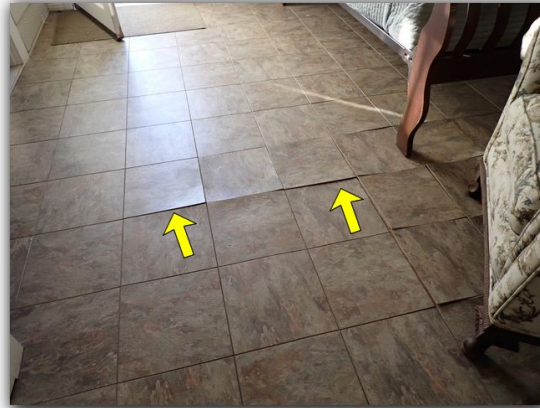
- Loose floor tiles were observed in the guest bedroom.

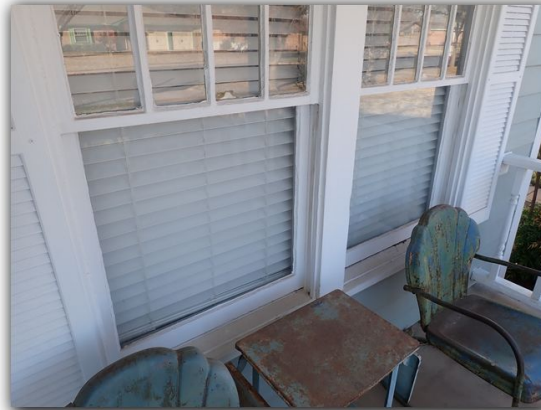
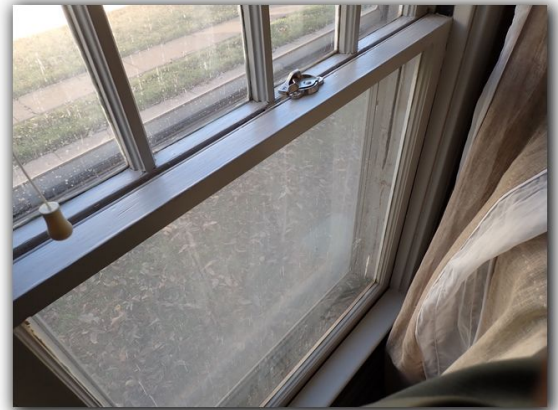
- One or more of the window screens were observed to be missing.

- **Note:** I was unable to inspect the operation of some of the windows due to window treatments, personal effects, large, heavy or fragile storage and/or furniture.
- One or more of the windows were observed to be stiff and hard to operate in the various locations throughout the house.

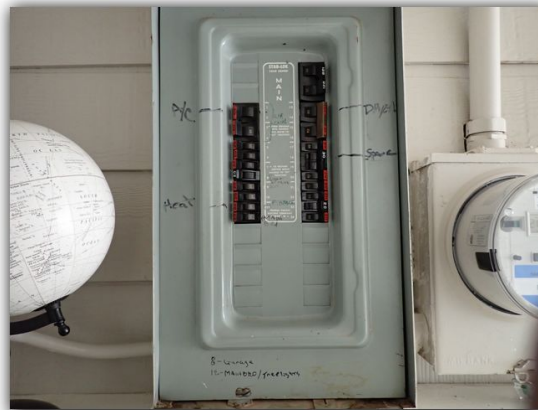
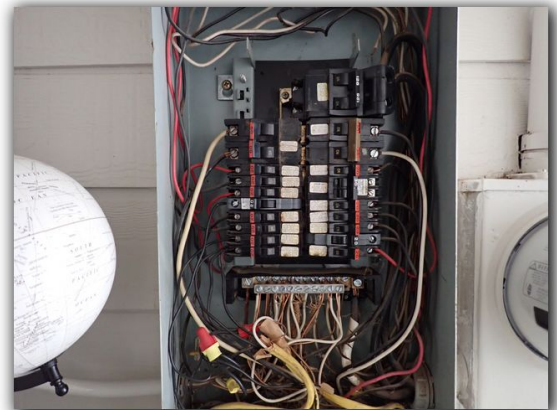
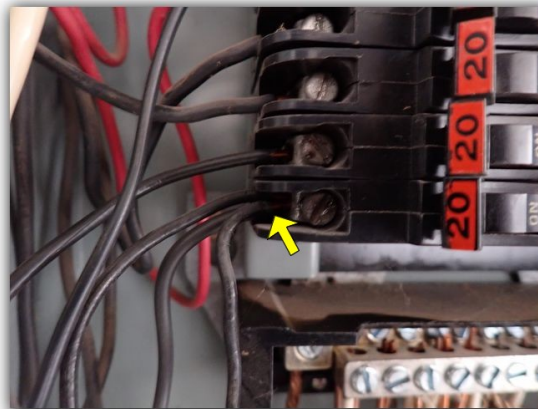
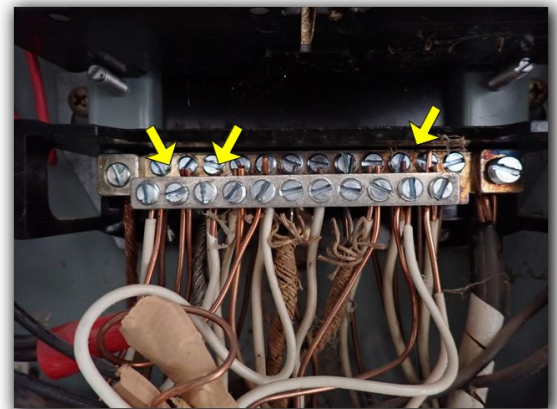
- The electrical cabinet does not appear to be properly bonded to the electrical system.
- There are multiple neutral wires secured under one lug/screw on the neutral bus bar. This type of installation does not meet current electrical standards. These conditions may not have violated building codes or common practices at the time of the construction of the home, or they may have been “grandfathered” because they were present prior to the adoption of codes prohibiting such conditions.

- One or more of the breakers in the electrical cabinet were observed to be double lugged (i.e. two wires under one screw). The breakers in place are not listed or labeled for this type of installation and should be corrected as necessary.

- **Notice:** There is a Federal Pacific Electric - FPE Panel Box in place at the time of the inspection. This panel box is known to have various problems and/or deficiencies. Full evaluation of this panel box is beyond the scope of this inspection. You are strongly encouraged to have the panel box further evaluated by a qualified electrician prior to the expiration of any time limitations such as option or warranty periods.

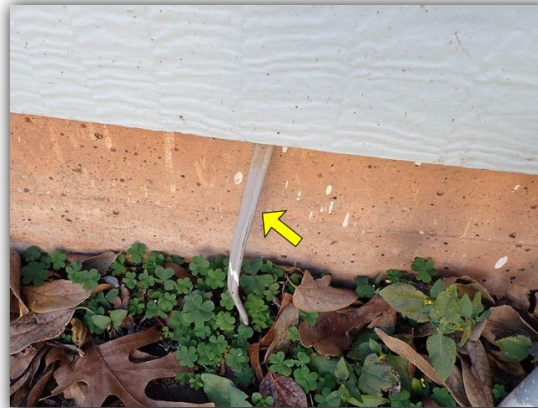
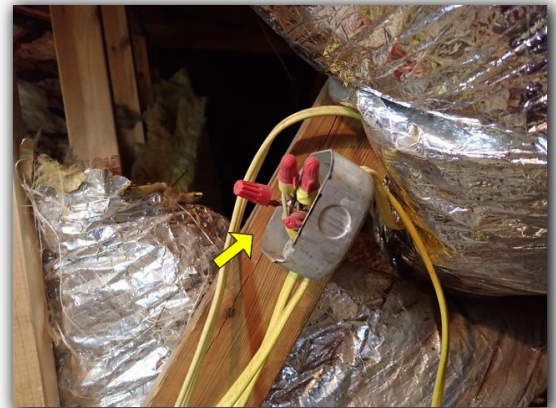
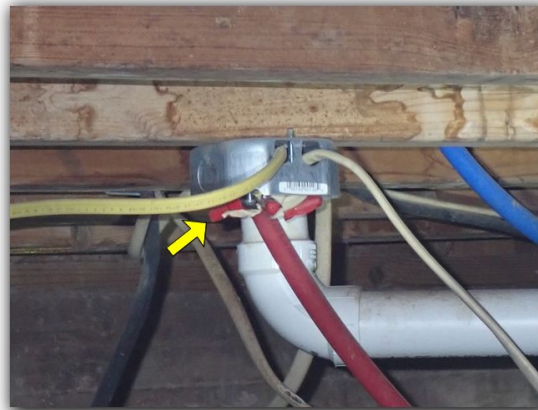
- Wires exposed to the outside elements (i.e. outside weather conditions) should be protected by ridged conduit. There are exposed wires located on the north side of the structure.
- Open electrical junction box(es) were observed in the attic area. All open junction box(es) in the attic should be properly enclosed.
- Open electrical junction box(es) were observed in the crawl space area. All open junction box(es) in the crawl space should be properly enclosed.

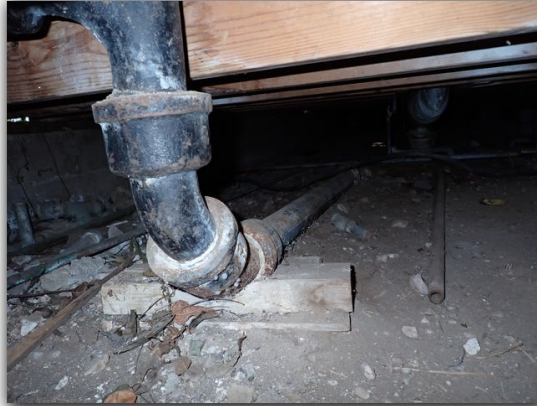
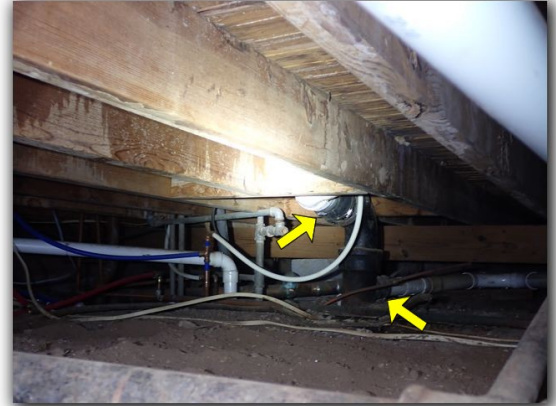
- The cast iron plumbing system has visible rust and corrosion on the exterior surfaces of the piping system. This is a good indicator that failures may occur in the near future. Further evaluation of the cast iron plumbing system is recommended.
- There are visible leaks in the cast iron piping system under the master bathroom. Further evaluation of this condition is recommended.

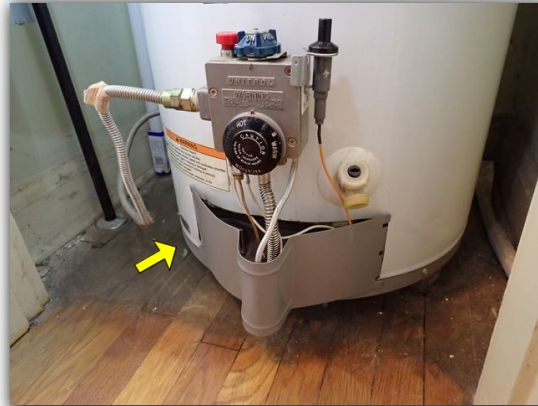
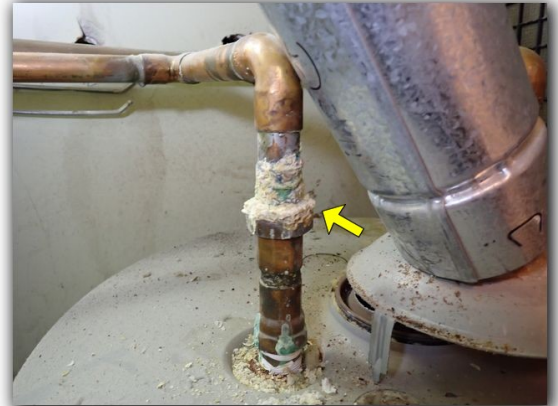
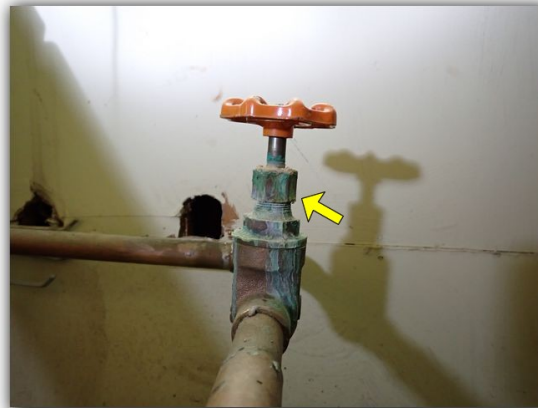
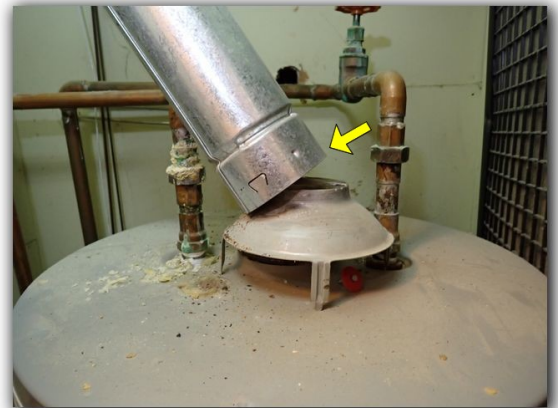
- The water heater did not light up at the time of the inspection. Recommend further evaluation and repairs as needed.
- There is no pan installed under the water heater. It is suggested that the correct sized pan and associated drain pipe system be installed per current installation requirements; at least the next time the water heater is replaced.

- Some corrosion was observed at the water supply connections at the top of the water heater.
- Some corrosion was observed on the water supply shutoff valve.

- The water heater flue is in poor condition and replacement is recommended for reasons of safety.
- The vent pipe is not properly mounted at the top of the water heater. This configuration will emit Carbon Monoxide into the heater compartment, which is a known safety hazard.

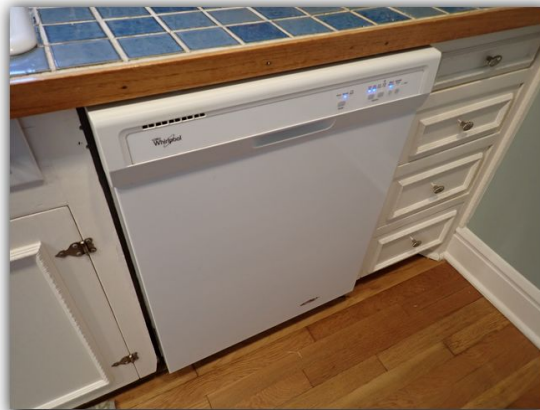
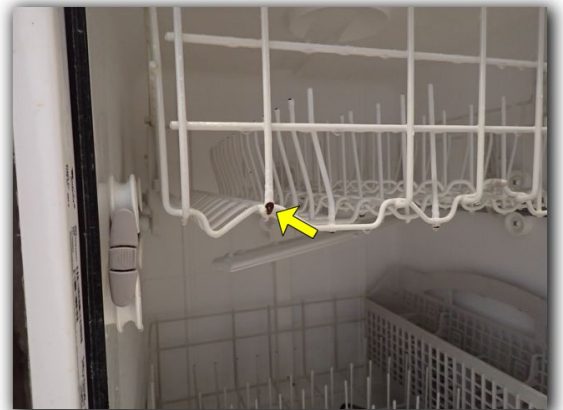
- Some rusting of the dishwasher interior components was observed.

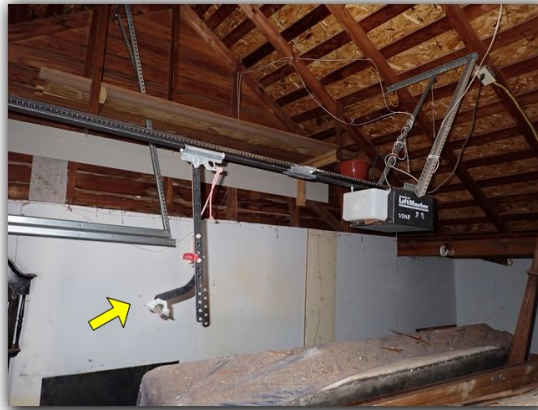
- The opener arm is pulling loose at the door connection and needs to be re secured.

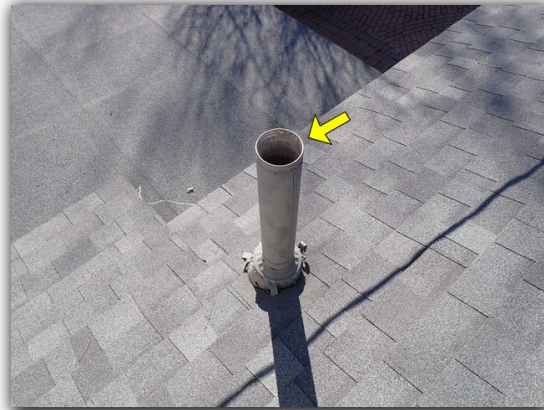
- A gas flue pipe appears to be used as dryer flue pipe.
- The exterior dryer duct termination cover is missing.
- The dryer duct termination is not equipped with a back draft damper. This condition does not meet current installation standards and should be corrected as necessary.
