**Brian Kruchkow**  
**1001 Sayles Blvd**  
**Abilene, TX 79605**

**December 18, 2023**

# PROPERTY INSPECTION REPORT FORM

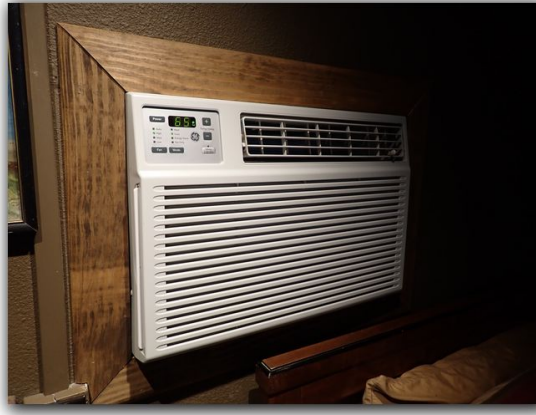
**Window Unit**

This component appears to be performing adequately at the time of this inspection.

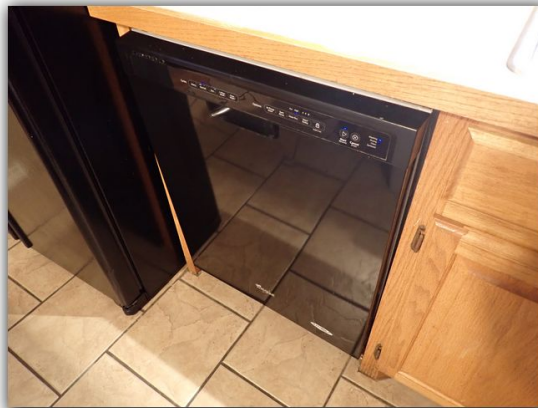
**Brand Name:** Whirlpool

This component appears to be performing adequately at the time of this inspection. It is achieving an operation, function or configuration relative to accepted industry standard practices with consideration of age and normal wear and tear from ordinary use.

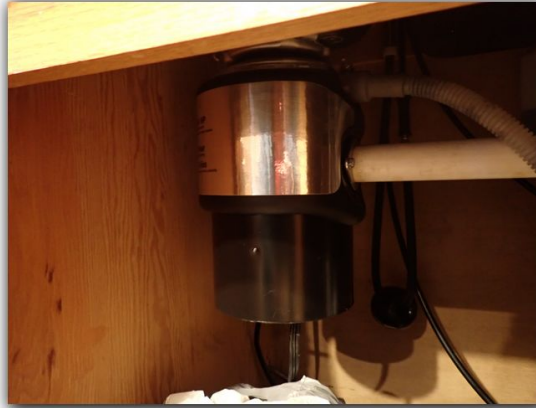
**Brand Name:** Badger

This component appears to be performing adequately at the time of this inspection. It is achieving an operation, function or configuration relative to accepted industry standard practices with consideration of age and normal wear and tear from ordinary use.

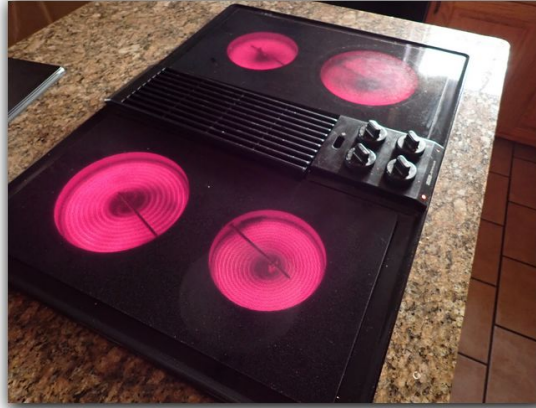
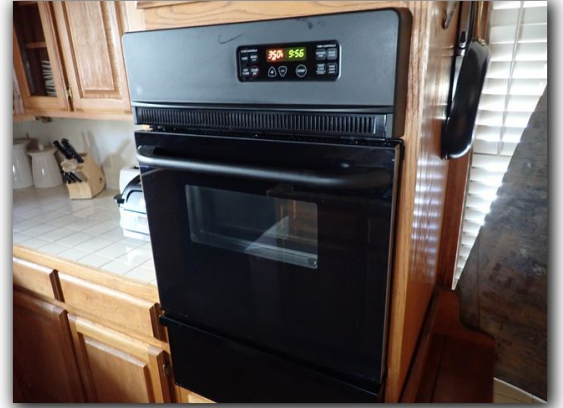
**Built-in Oven Brand Name:** General Electric – GE

The oven was set to 350 degrees. When tested, at least 30 minutes later, the temperature rose to 345 degrees and held that temperature. A +/- of 25 degrees is considered acceptable.

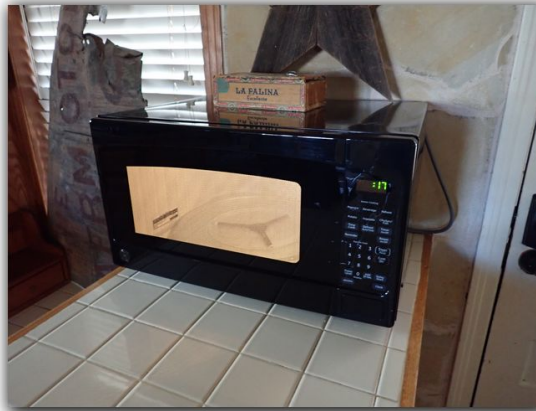
**Brand Name:** General Electric – GE

This component appears to be performing adequately at the time of this inspection. It is achieving an operation, function or configuration relative to accepted industry standard practices with consideration of age and normal wear and tear from ordinary use.
