**December 18, 2023**

# PROPERTY INSPECTION REPORT FORM

1002 & 1002.5 Amarillo St, Abilene, TX 79602

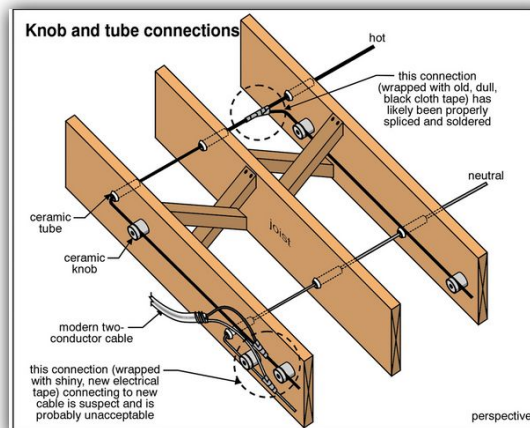
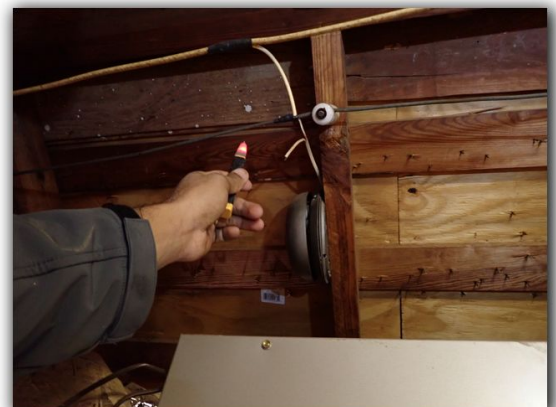
### Knob & Tube (Detached Garage)

- There is knob and tube wiring in use at the time of this inspection. This is an older obsolete type wiring system. Evaluation of the full integrity of the knob and tube system is outside the scope of this inspection. You should consult with your insurance carrier and an electrician familiar with older homes in this area if concerns exist with having knob and tube wiring in the structure.

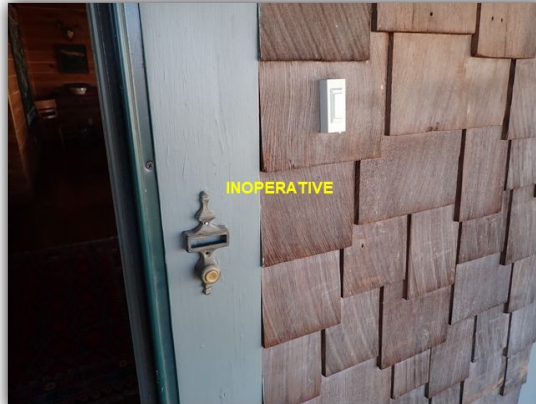
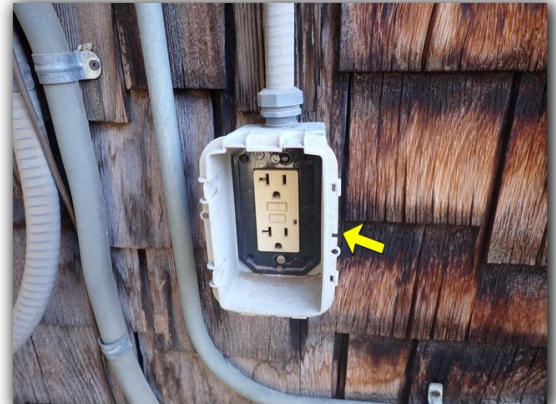
#### Doorbell / Chime

- The doorbells and/or associated components appear to be inoperative at the front door area.

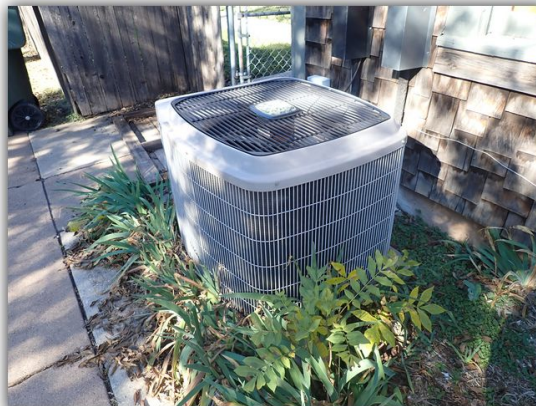
- Damaged, deteriorated and/or missing insulation on the refrigerant lines should be repaired or replaced at the outside condenser.

**Additional Notice from the Inspector:** It is the opinion of this Inspector, this component may be functioning as intended or in need of minor repairs, you should be aware that this is an older component and the future life expectancy cannot be determined. You can continue to use and service this component until replacement is necessary.

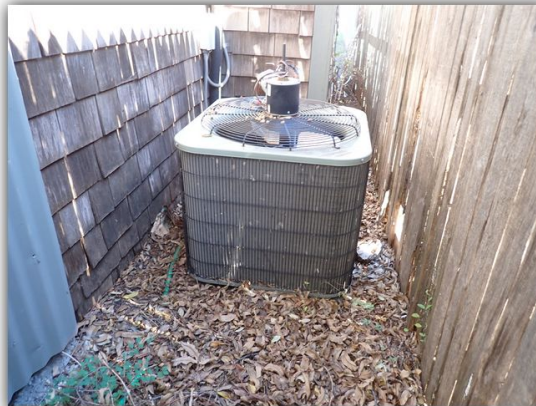
**Additional Notice from the Inspector:** It is the opinion of this Inspector, this component may be functioning as intended or in need of minor repairs, you should be aware that this is an older component and the future life expectancy cannot be determined. You can continue to use and service this component until replacement is necessary.

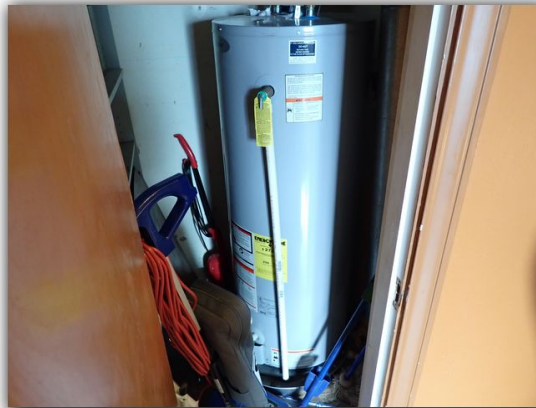
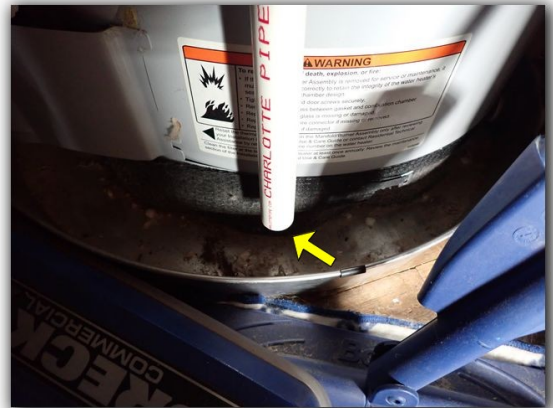
- The temperature and pressure relief discharge pipe is terminating into the water heater drain pan. Under current building standards, this discharge pipe should run downward to the exterior of the structure, turn downward, and terminate within 6-inches of the ground.

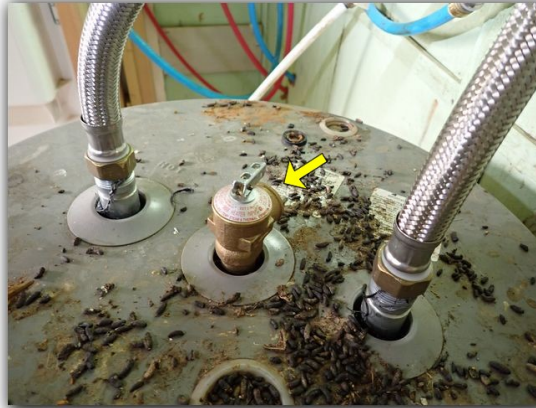
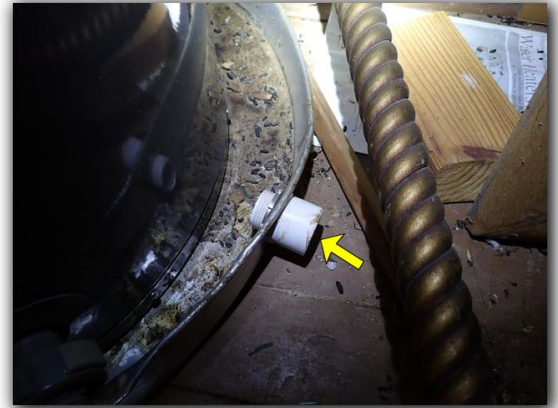
- There is no drain line installed for the water heater pan. The pan should have a drain line installed that should terminate over a suitably located indirect waste receptor or shall extend to the exterior of the building and terminate not less than six-inches (6") and not more than twenty-four inches (24") above of the ground.
- There is no temperature and pressure relief valve (TPR) discharge pipe in place at the time of this inspection. For safety reasons, it is recommended that a TPR valve discharge pipe be installed. Under current building standards, the discharge pipe should run downward to the exterior of the structure, turn downward, and terminate within 6-inches of the ground.
- Note:** Visible evidence of rodent activity was observed. It is recommended to have a Certified Pest Control Operator further evaluate this condition and make corrections as necessary.

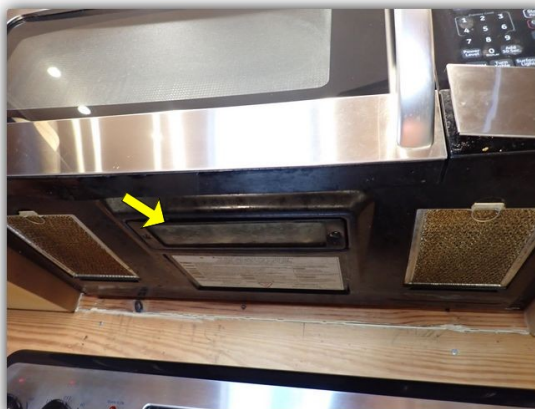
- The light at the range hood is inoperative.

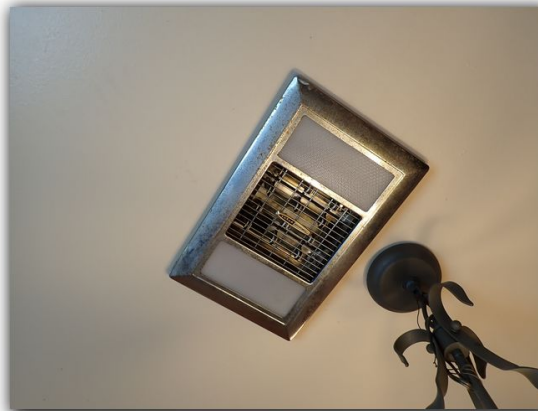
- The mechanical exhaust vent fan appears to be inoperative in the hall bathroom.
- **Note:** The bathroom exhaust vents were observed to be venting into the attic area and not to the exterior of the structure. This is an “as-built” condition per local building codes but we are required to mark it as deficient per the TREC standards of practice.

- The bathroom heater is inoperative in the hall bathroom.

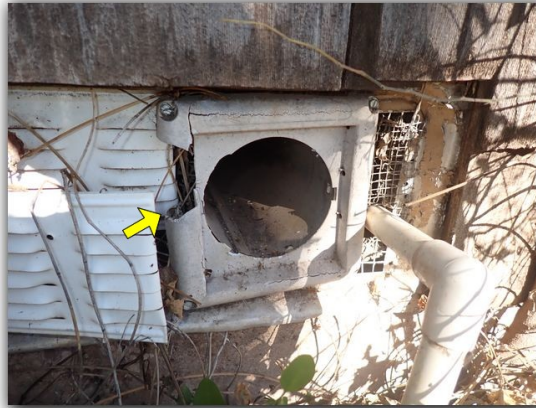
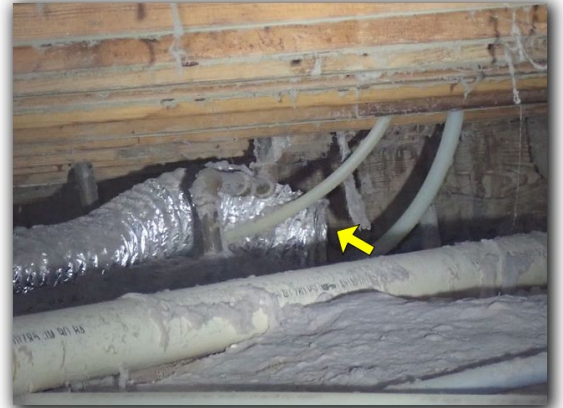
- The exterior dryer duct termination cover is damaged.
- The dryer duct termination is not equipped with a back draft damper. This condition does not meet current installation standards and should be corrected as necessary.
- The dryer duct is separated in the crawl space area.
- The material used for the dryer duct is not listed or labeled for this type of installation.
