Brian Kruchkow
1509 & 1511 Yeomans Rd
Abilene, TX 79602

December 18, 2023

PROPERTY INSPECTION REPORT FORM

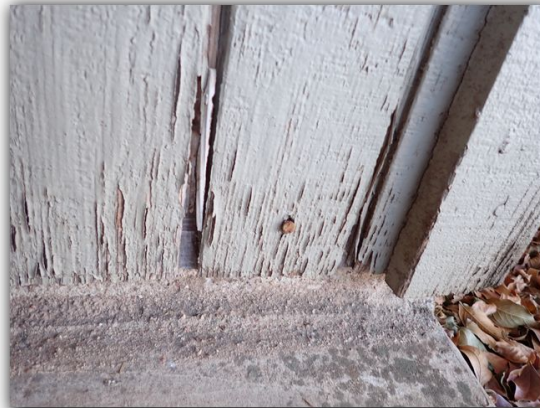
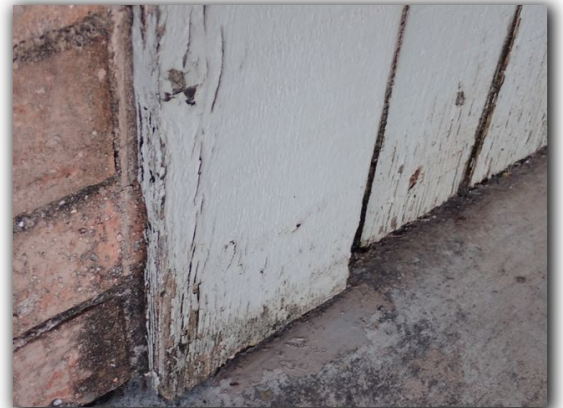
- Some of the exterior wood type surfaces need a fresh coat of paint.

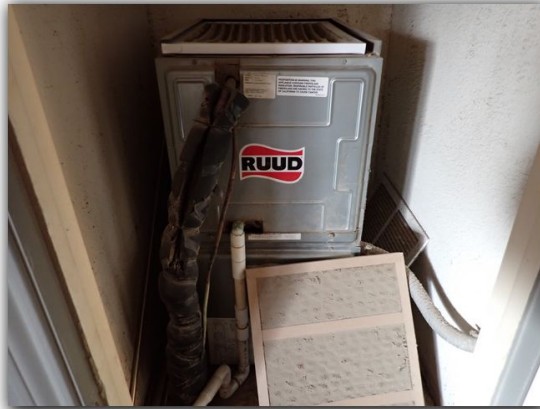
This component appears to be performing adequately at the time of this inspection. It is achieving an operation, function or configuration relative to accepted industry standard practices with consideration of age and normal wear and tear from ordinary use.

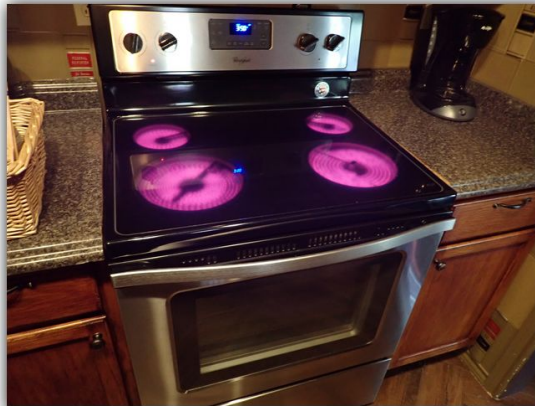
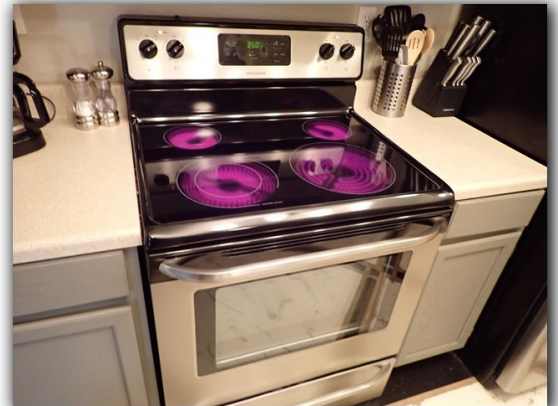
- Range must be secured by **Anti-Tip bracket** supplied.
- If the Anti-Tip device supplied with the range does not fit this application, use the universal Anti-Tip device WB2X7909.
- See instructions to install (supplied with bracket).
- Unless properly installed, the range could be tipped by stepping or sitting on the door. Injury may result from spilled hot liquids or from the range itself.
