Brian Kruchkow
1918 S 9th St
Abilene, TX 79602

December 18, 2023

PROPERTY INSPECTION REPORT FORM

Brian Kruchkow <i>Name of Client</i>	12/18/2023 <i>Date of Inspection</i>
1918 S 9th St, Abilene, TX 79602 <i>Address of Inspected Property</i>	
David Renner <i>Name of Inspector</i>	20502 / NAWT #12181ITC <i>TREC License #</i>

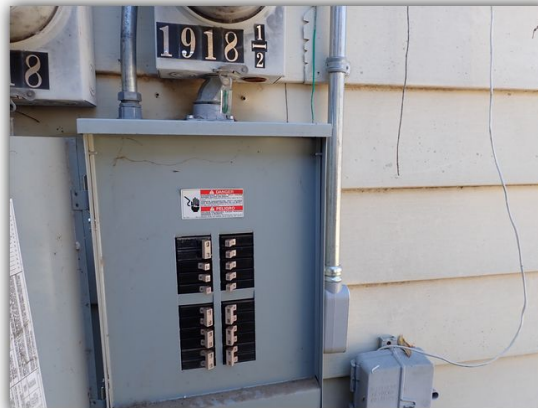
Panel Box #4

Box Rating and/or Main Disconnect Rating: Rating Not Determined / Box No Properly Labeled

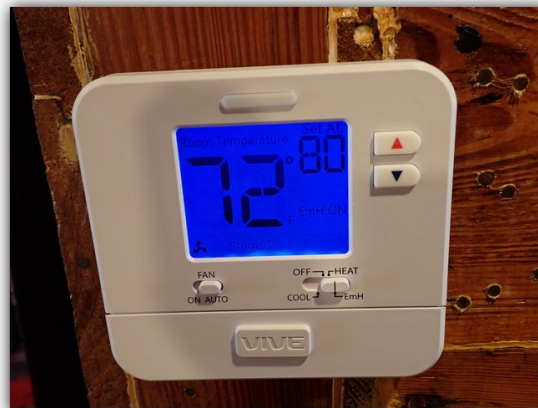
- The emergency heating equipment appears to be inoperative at the time of the inspection.

Note: When D (**D = Deficient**) is checked, it is recommended that this item be fully investigated by a Qualified / Licensed HVAC Technician, prior to the expiration of any time limitations such as option or warranty periods, to fully evaluate the integrity of the equipment.
