Brian Kruchkow
942 Amarillo St
Abilene, TX 79602

December 18, 2023

PROPERTY INSPECTION REPORT FORM

Brian Kruchkow <i>Name of Client</i>	12/18/2023 <i>Date of Inspection</i>
942 Amarillo St, Abilene, TX 79602 <i>Address of Inspected Property</i>	
Felipe Cruz <i>Name of Inspector</i>	22478 <i>TREC License #</i>

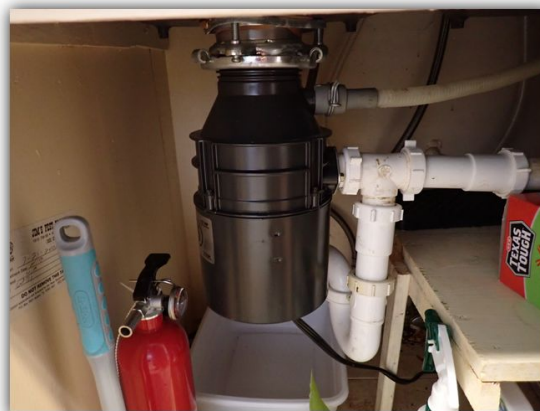
Brand Name: Badger

This component appears to be performing adequately at the time of this inspection. It is achieving an operation, function or configuration relative to accepted industry standard practices with consideration of age and normal wear and tear from ordinary use.
